### 11.1 Structural Report by Northrop Engineers

CR140212e01  
12<sup>th</sup> August 2014

### **St Johns Reid – Structural Audit**

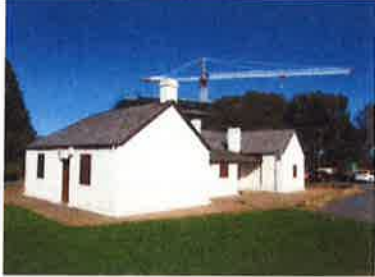
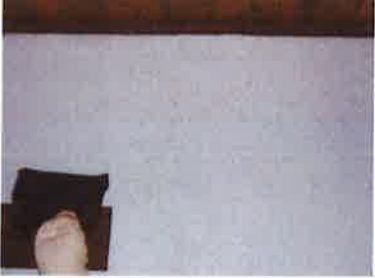
<p>Very minor brickwork cracking due to foundation movement</p>

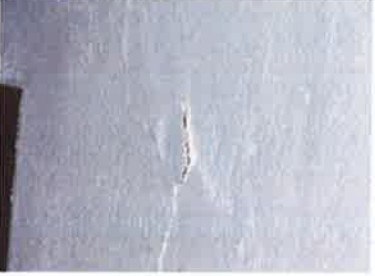
<p>Cracking and delaminating render</p>

- Monitor extent of drummy render. Repair may be required in time.
- Replace damaged floor board.

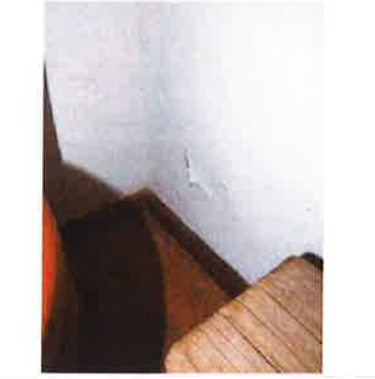
<p>Flaking paint and render, possible rising damp in the dining room.</p>

- Monitor extent of rising damp. Repair may be required in time. Repair could involve the installation of an injected or retrofitted damp proof membrane. Options are shown in appendix F

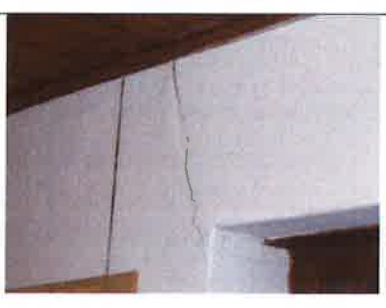
<p>Diagonal cracking due to foundation movement</p>

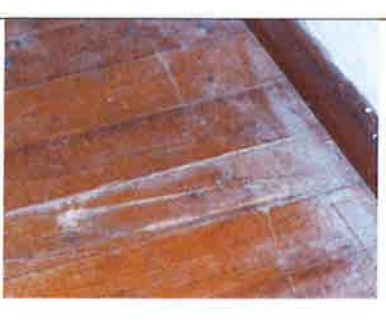
<p>Broken floor board</p>

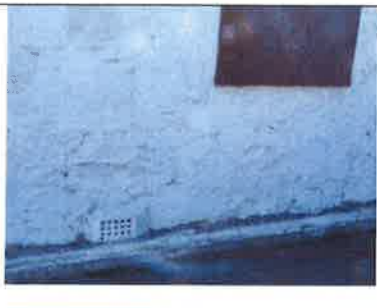
<p>Minor cracking in painted stone wall</p>

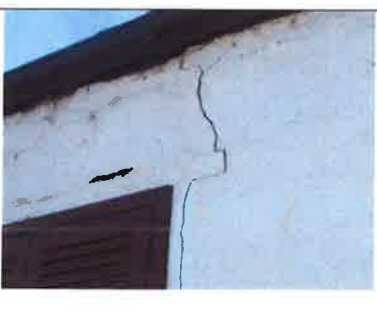
<p>Crack in painted stone wall</p>

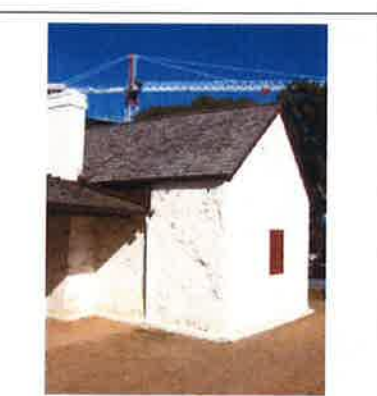
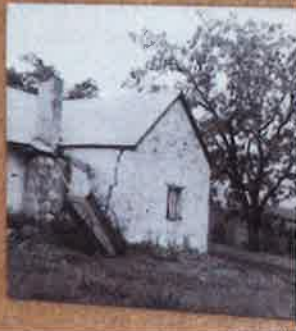
</div> <p>Interestingly the crack in the right hand photo which is hanging on the wall in the School House was repaired many years ago. The left hand photo shows the same wall today. There is no sign that the crack is reoccurring.</p>

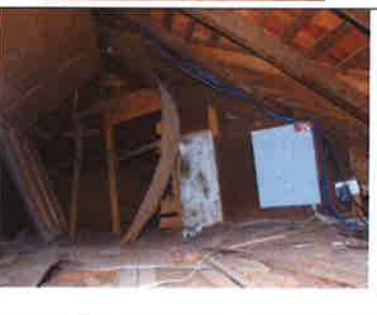
<p>Ceiling space is dry but has recent timber flooring and debris</p>

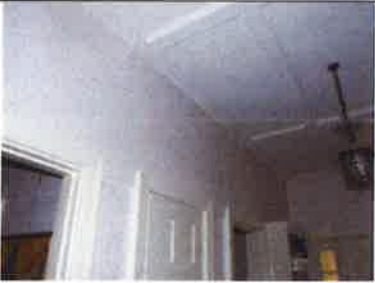
<p>Cracking in rendered walls over doorways</p>

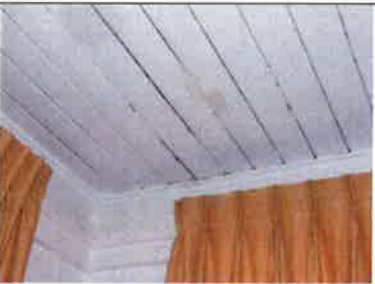
<p>Possible nesting material showing through ceiling lining</p>

- The roof framing should be further investigated and repaired as necessary.
- The bird nesting in the flat roofed portions should be removed.
- Internal cracking needs to be either treated as part of ongoing maintenance or more permanently rectified. The choice of approach

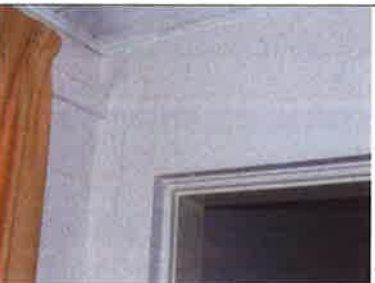
- There are numerous examples of cracking in the walls inside the residence.
- The cracking is generally the result of foundation movement and is minor but extensive.

<p>Wall cracks are minor but extensive</p>

- Given the extent of damage in this instance and the fact that it is generally not structurally detrimental a simple patch and paint on an ongoing basis could be effective. Sample details are shown in appendix C. From a maintenance perspective the cracks would need to be filled and painted on a regular basis.

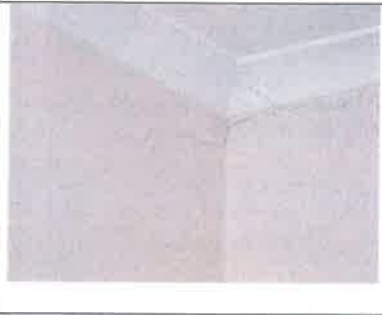
<p>Wall cracks</p>

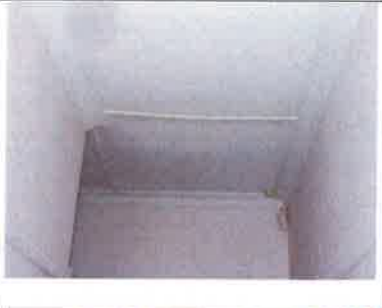
<p>Ceiling sag</p>

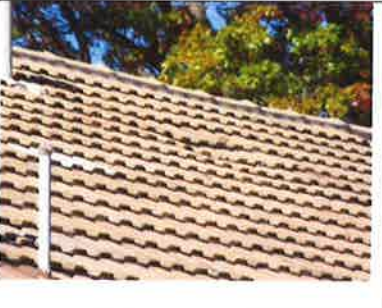
<p>Kinked tiles directly over broken and repaired rafters</p>

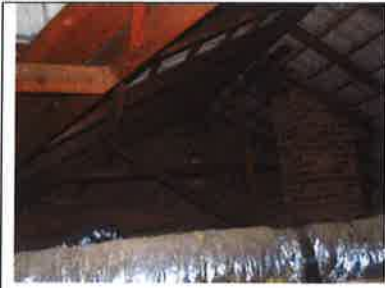
- The roof framing timbers are Oregon. The roof is sparsely framed but appears adequate. Nevertheless there are several examples of split, cracked and warped timbers. This is not uncommon with Oregon. There is evidence of previous repair.

Split rafters

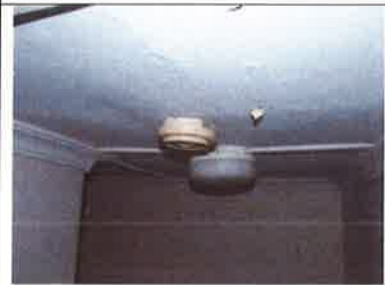
Sagging and damaged ceiling

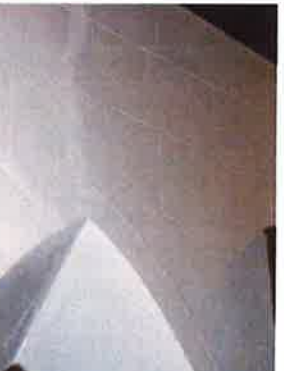
<p>Cracking in arch has previously been repaired</p>

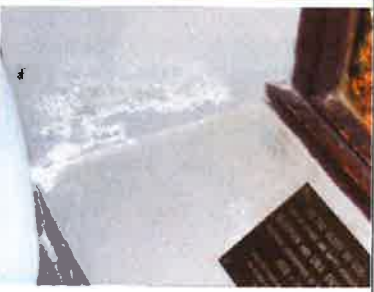
<p>Rising damp on window sill</p>

- Monitor the dampness for evidence that it may be causing damage.
  - Consider the installation of a new damp proof membrane. This can be by way of an injected chemical membrane or an electronic form of protection. There are many products and systems available and these should be thoroughly investigated before a system is chosen. Some options are shown in appendix D.

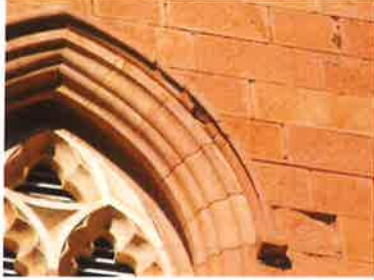
- Sections of stone corbels are missing from around some windows particularly around the higher windows to the bell tower.
- The crypt is dry and performing well.

<p>Isolated deteriorating stones and missing corbels</p>

- Consider the relative weight compared to the original timber shingle of any future roofing material proposed for the building.
- Replace missing stone corbels when appropriate. In the meantime inspect these areas closely to ensure the remaining pieces are sound and not likely to fall.

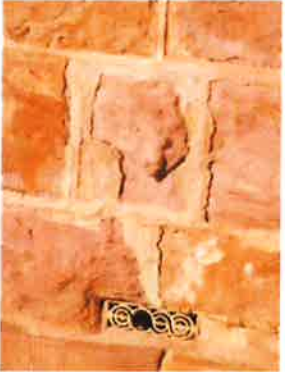
- There is evidence of localised deterioration of some individual stones in the façade. This is most likely the result of decay of softer stone rather than a rising damp problem. They occur at all levels and in some cases quite high in the façade.

<p>Isolated deteriorating stones</p>

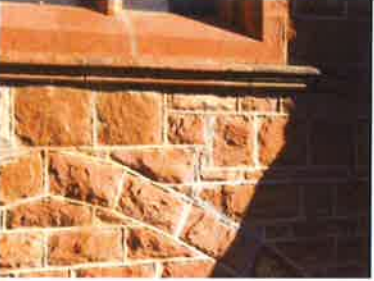
- There is some recent repair work to the stone that has been very poorly executed in that it uses what seems to be a cement rich mortar. This is both elastically wrong and could in time have a detrimental effect on the performance of these sections of wall.

<p>Cement rich mortar repair</p>

- Remove cement rich mortar.
- Replace any isolated deteriorated stonework using lime rich mortar to match the original stone construction.
- Whilst rising damp is not causing widespread damage at the moment it is becoming more apparent in the colder months and should not be left unaddressed. A considered approach to mitigating dampness should be investigated. Options include:

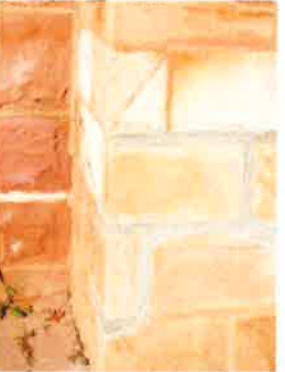
<p>Cement rich mortar repair</p>

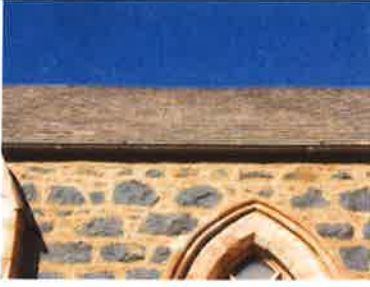
<p>Minor cracking over arch</p>

- Minor cracking in the walls should be monitored and localised repair and replacement undertaken as required. Monitoring should be formal with measurements taken and recorded on a regular basis for future scrutiny.

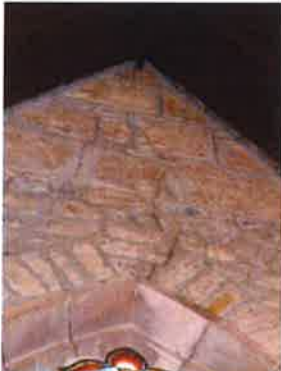
<p>Minor cracking over arch</p>

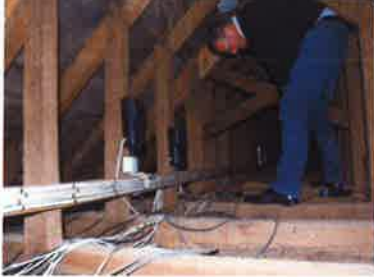
<p>Ceiling space is dry and the timbers and connections appear to be performing well</p>

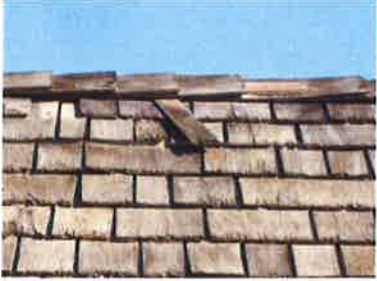
<p>Loose timber shingle</p>

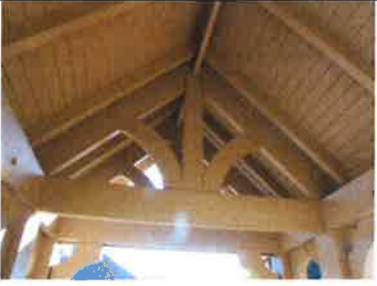
<p>Roof timbers are performing well</p>
