# ANGLICAN CHURCH OF ST. JOHN THE BAPTIST CANBERRA

## A CONSERVATION PLAN

ANGLICAN CHURCH OF ST JOHN THE BAPTIST, CANBERRA  
A CONSERVATION PLAN, MAY 1984  
SHORTENED & UPDATED REPORT, MARCH 1994

JOHN GOLDSMITH FRAIA - HONORARY ARCHITECT

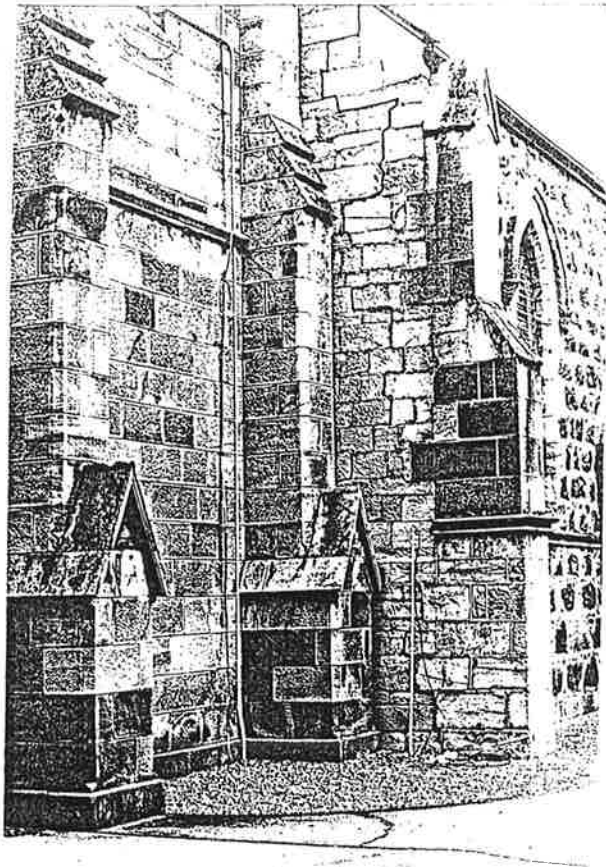
*Unightly surface conduits on south wall of tower.*

New switch gear replaces the old system on the Bellingring floor and the unsightly conduits on the north wall of the tower have been removed. An intricate system of concealing the new wiring in the space between the tower and nave was evolved, together with drilling a 100mm (4") hole 1.2 metres long diagonally through the tower wall in which to run the cables into the switch gear location.

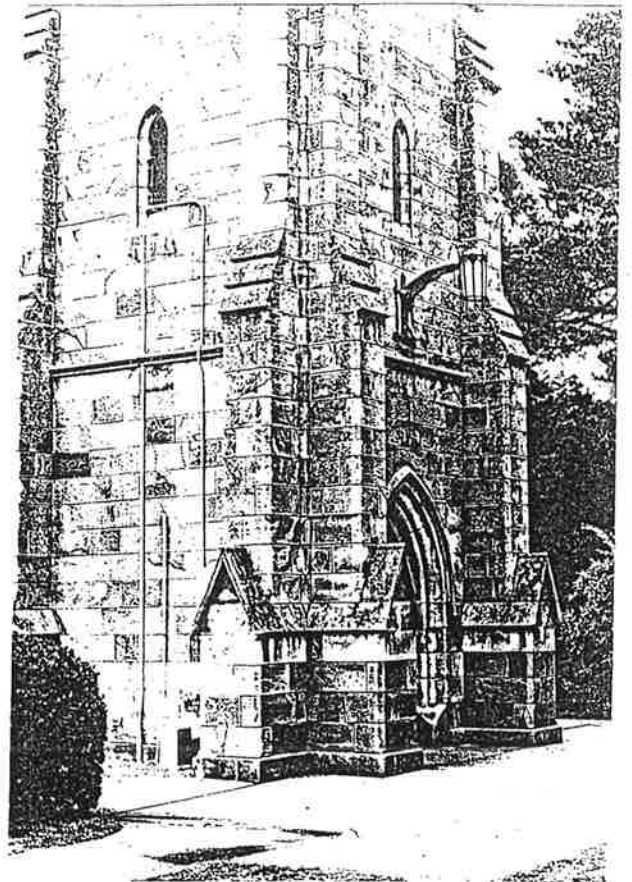
*Unightly surface conduits on north wall of tower.*

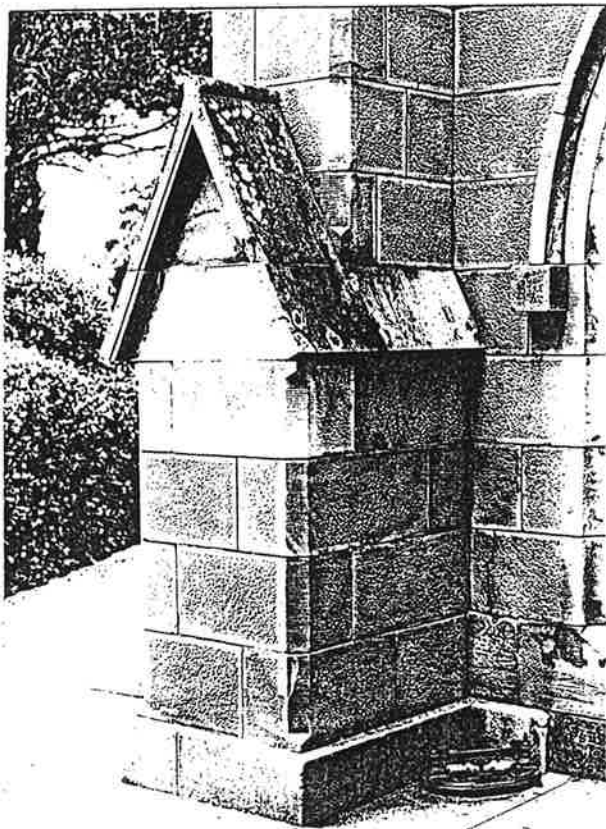
*Damage to buttress cap by West Porch door.*

The buttress capping stones in eight locations were removed, checked and a great deal of stone work discarded as being unsound. New stones were obtained and cut and shaped as replacement caps faithfully made to match the originals, and these have been fitted into position.

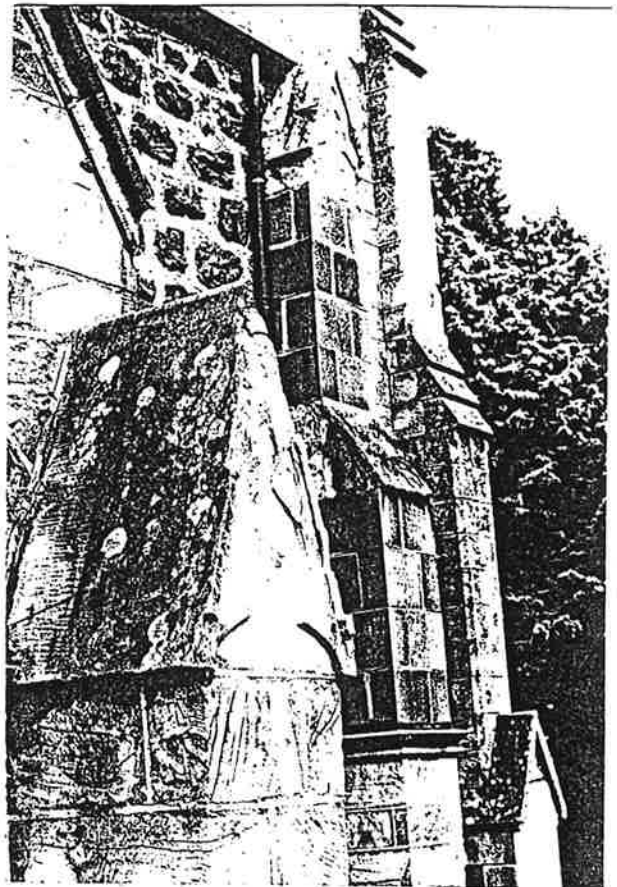
*Flaked & spalling to buttress caps.*

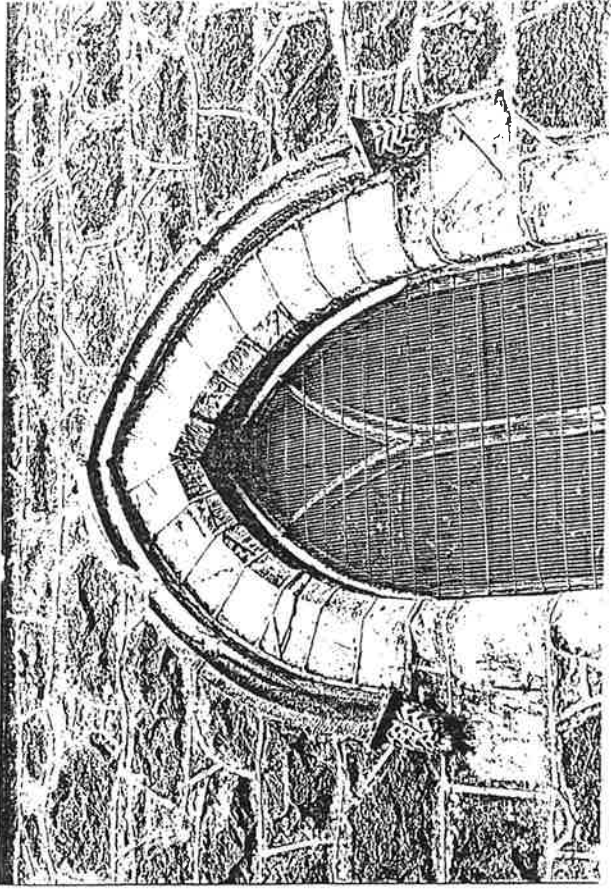
*Flaking & spalling to window W5.*

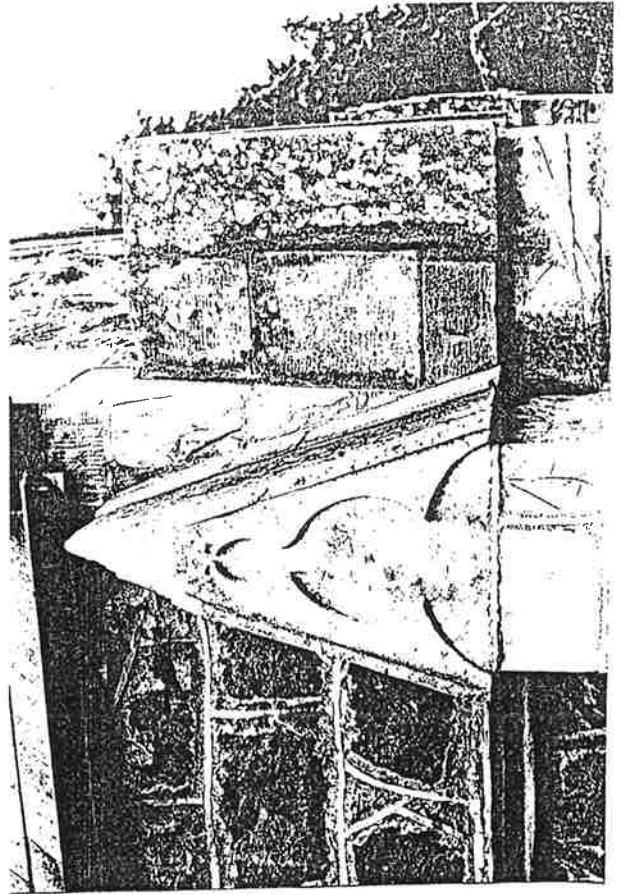
*Flaked & spalled buttress cap.*

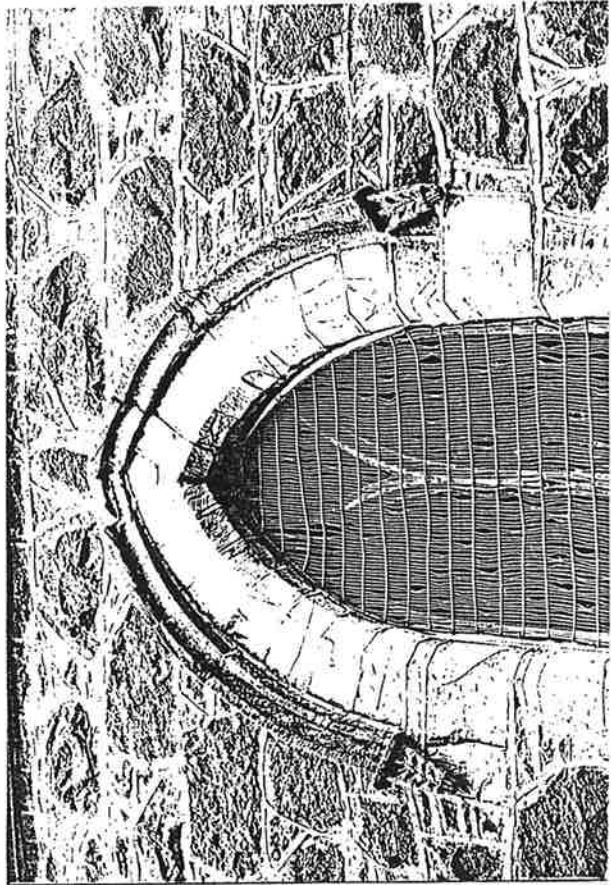
*Flaking & spalling to weather moulding to window W2.*

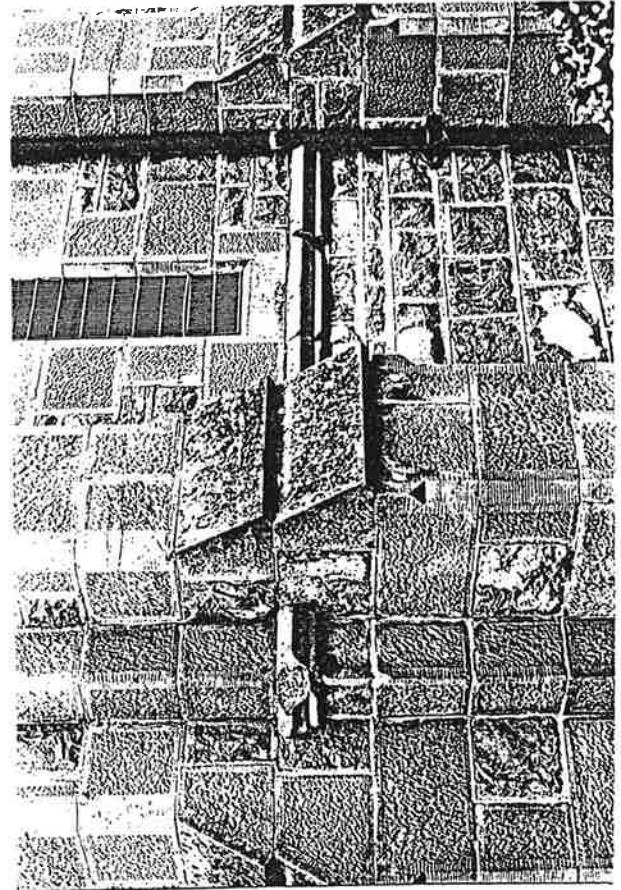
*Cracking & chipping of string course.*

Several more buttress caps; string course below windows all round; window and door head weather mouldings; replacement of some wall stones and renovation of portion of the chancel arch.

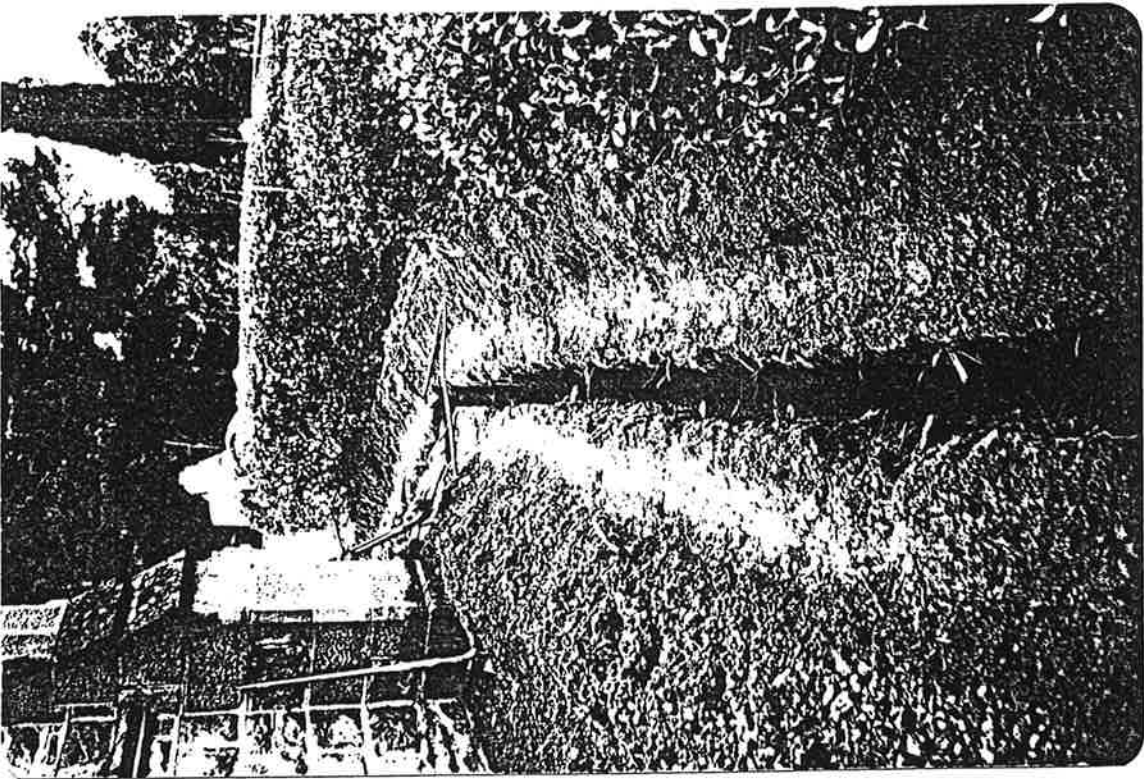
1.5 m. x 800 m excavation

Stabilisation work in progress

July - Sept 1987.

This action took the form of constructing an inground concrete wall about 1.5 metres (5 feet) deep and about 200mm (8 inches) wide all

around the building about two metres (6 feet 6 inches) out from the perimeter walls. Concrete slabs were laid from the Church walls out to the top of the inground walls, stormwater drainage was renewed and channelled away. the surface of the slabs was then paved with cobble stones.

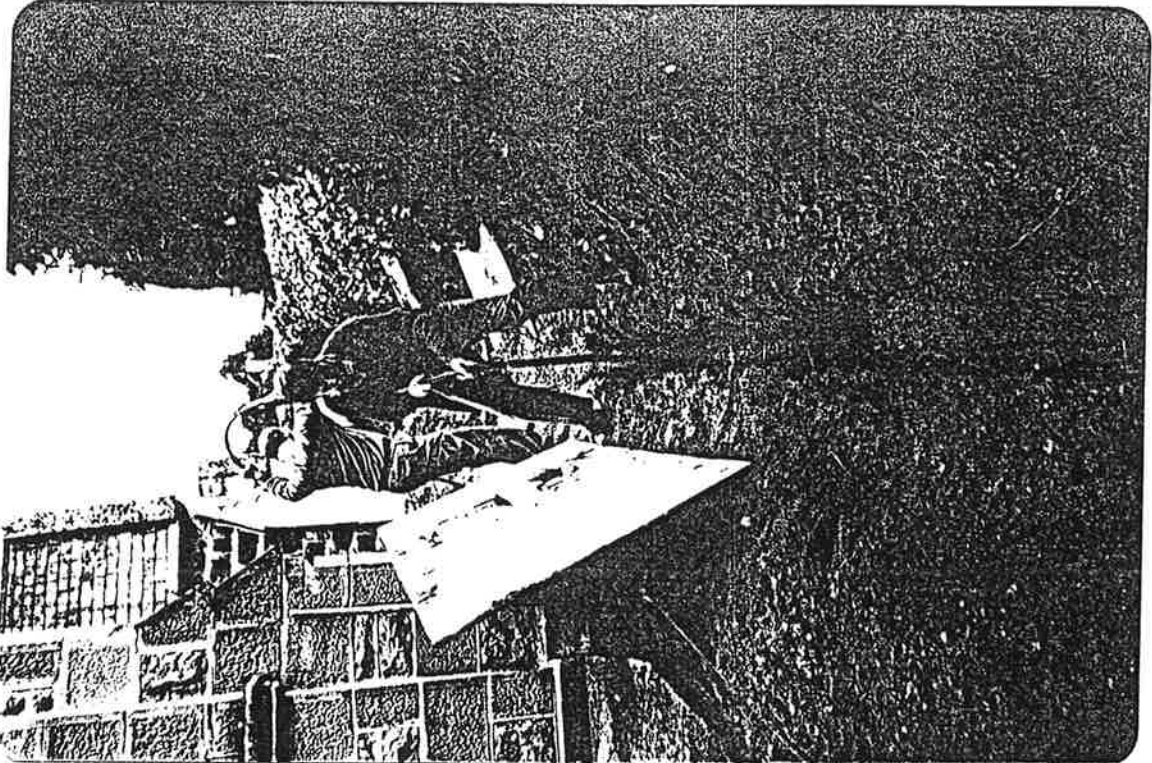
In ground concrete wall being poured

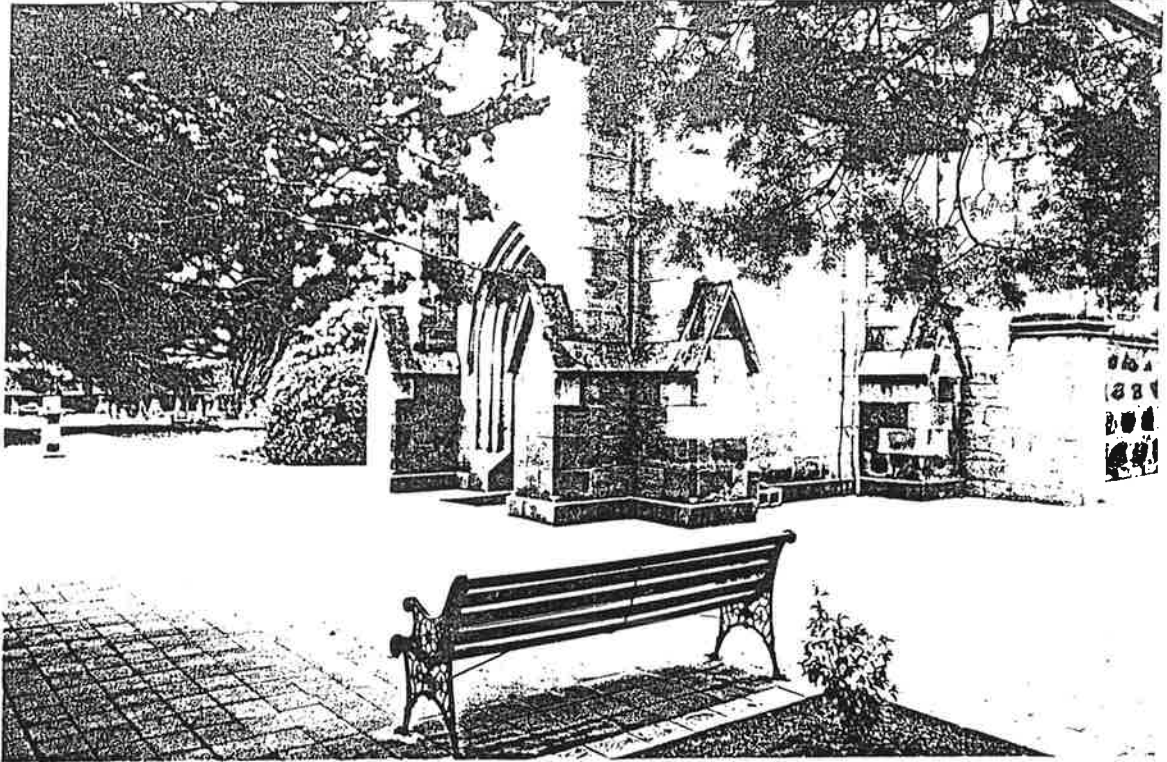
*Church stabilisation - In ground walls and surface slabs with finishing paving completed*

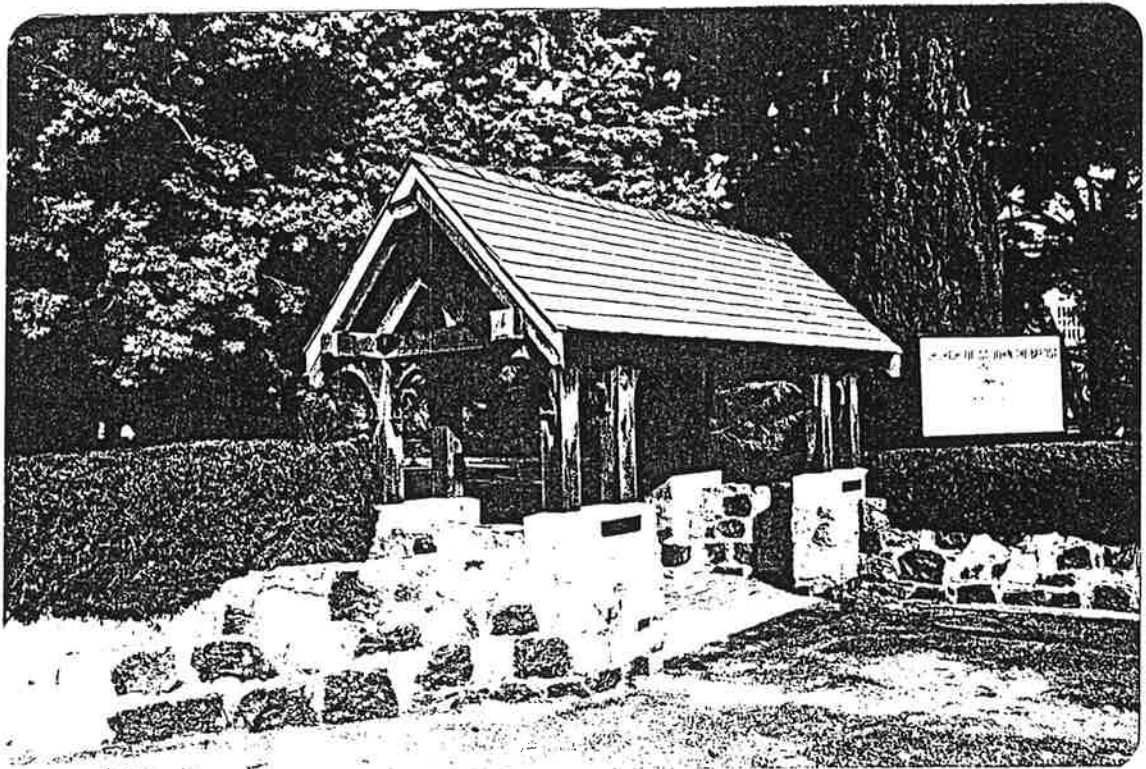
*Restoration of West hych gate*

**K3. LYCH GATES:** Also in 1987, both the east and west lych gate structures were restored by rebuilding parts of the stonework, replacing damaged timbers in the frames and reshingling. These were covered with cedar shingles because the cockatoos are too timid to descend to the lower level of the lych gate structures.

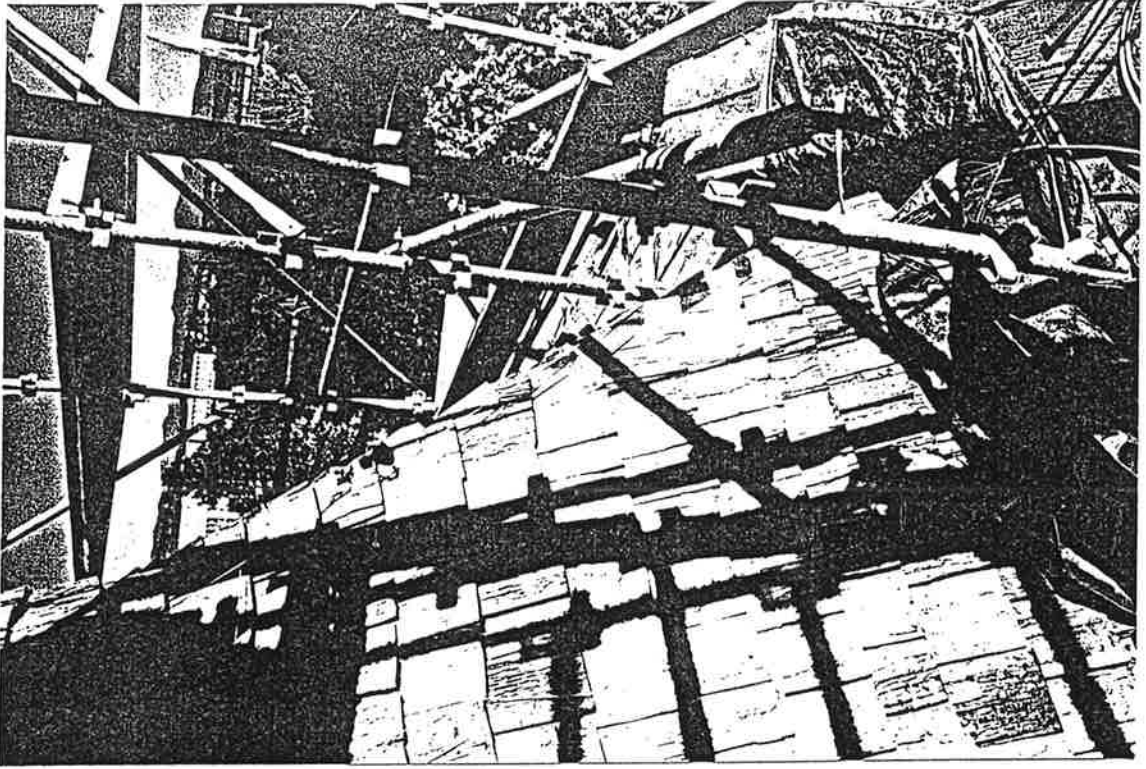
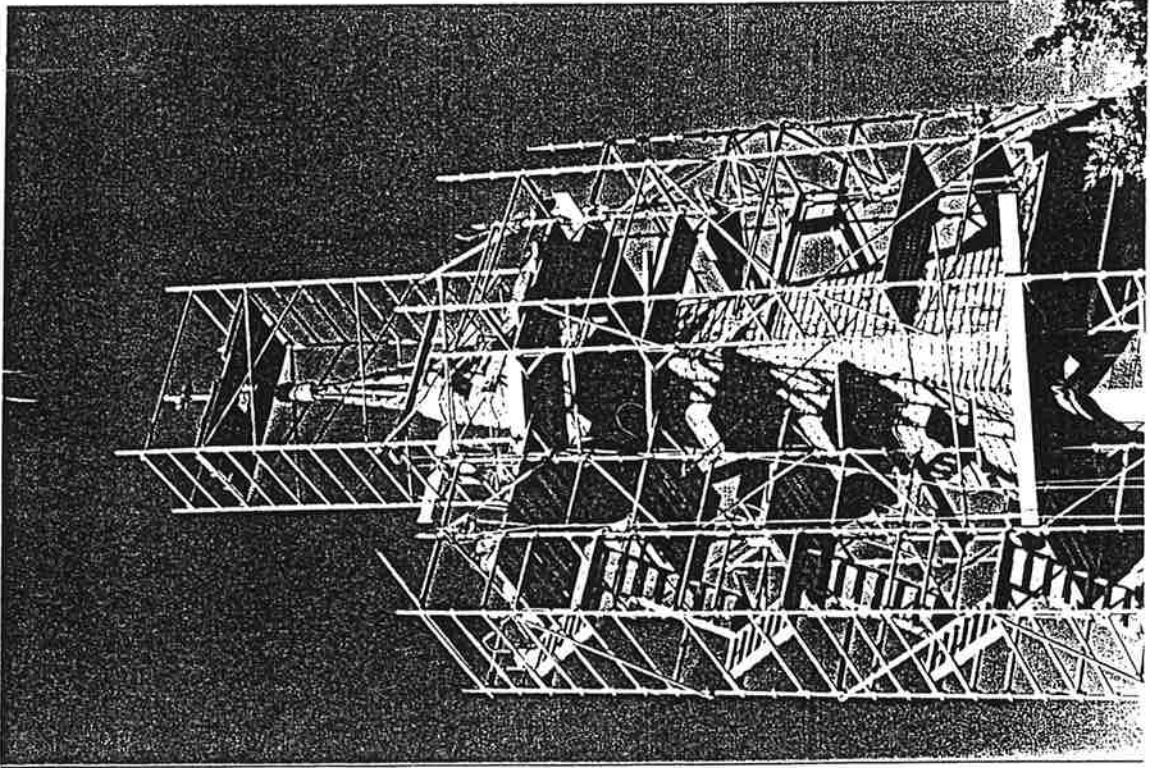
**K2. SPIRE:** During 1987 it became evident that serious damage was being caused to the cedar shingles on the spire by flocks of cockatoos and galahs. They were chewing the soft cedar and dropping the pieces in piles all around the porch. A decision was taken to reshingle in hardwood shingles and a supply of these made from split Casurina Torulosa, commonly known as Forest Oak, was discovered in Northern N.S.W. These had been successful in reshingling such important buildings as the Hyde Park Barracks and Cadman Cottage in Sydney. The reshingling took place between May and August 1988. During the work and with the advantage of the scaffolding a careful examination of the cross was found to be in a very defective state with advanced stages of rust settled in.

Restoring of Spire. June - Sept 1988

During the dismantling of the cross a bullet was found lodged in the wooden inner material. This had penetrated the outer thin metal lining and accelerated the rusting process. Both the metal cap and the cross were replaced in new material, with the cross in square copper tubing.

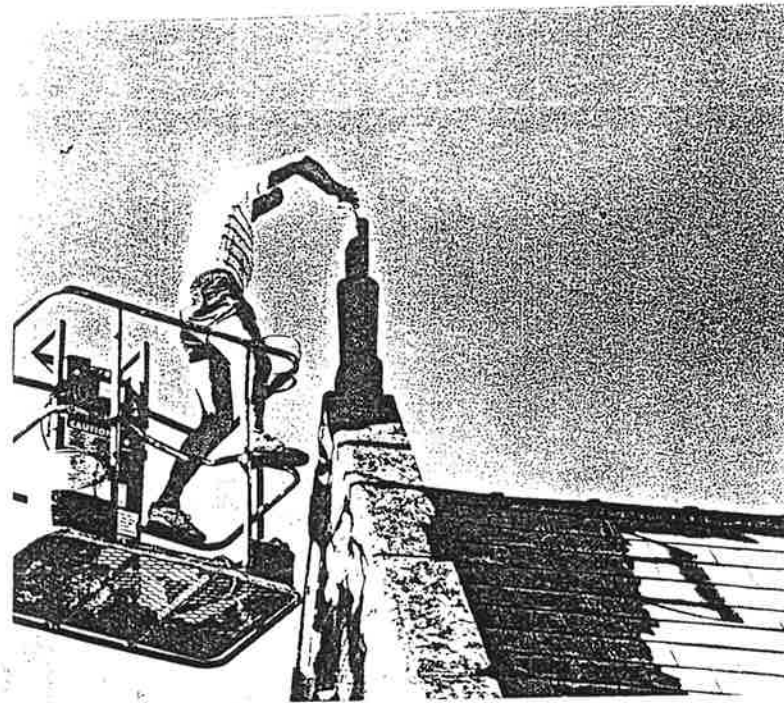
*Preparing to fix replacement Cross*

*Replacement of Cross to Chancel Gable  
after lightning strike.*

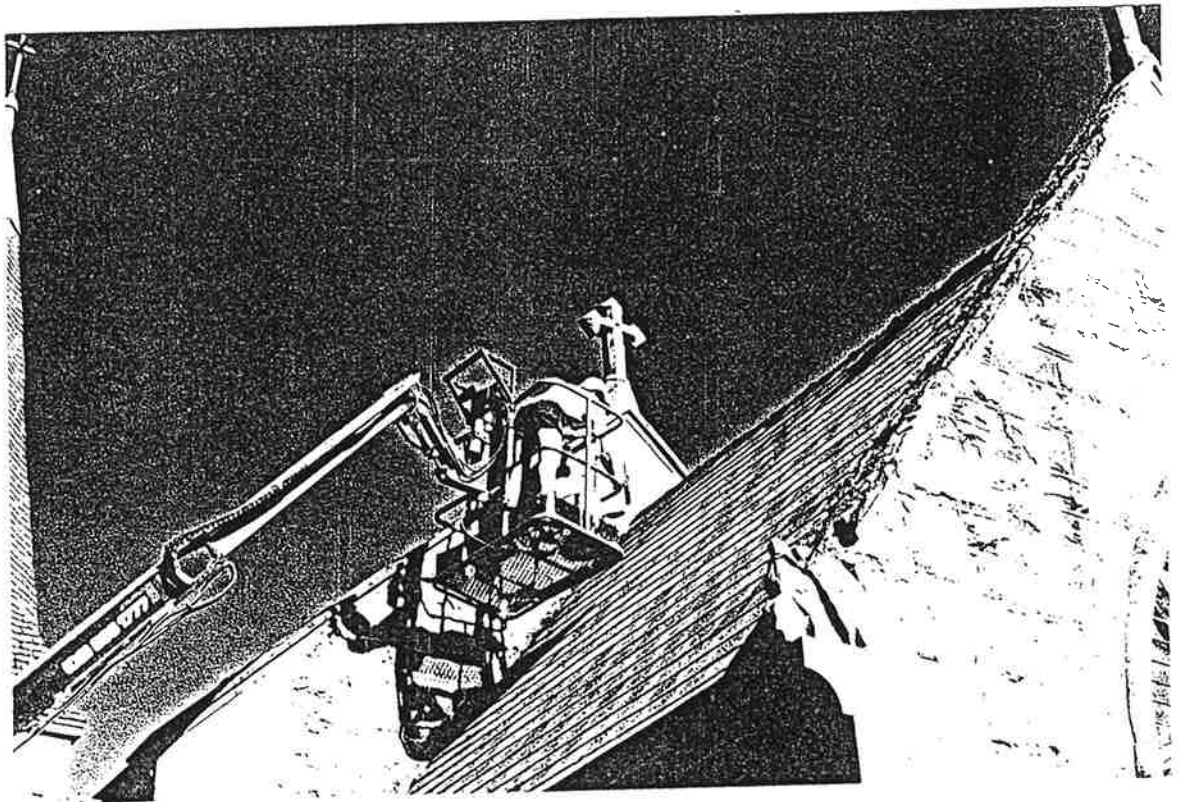
*Cross fixed.*

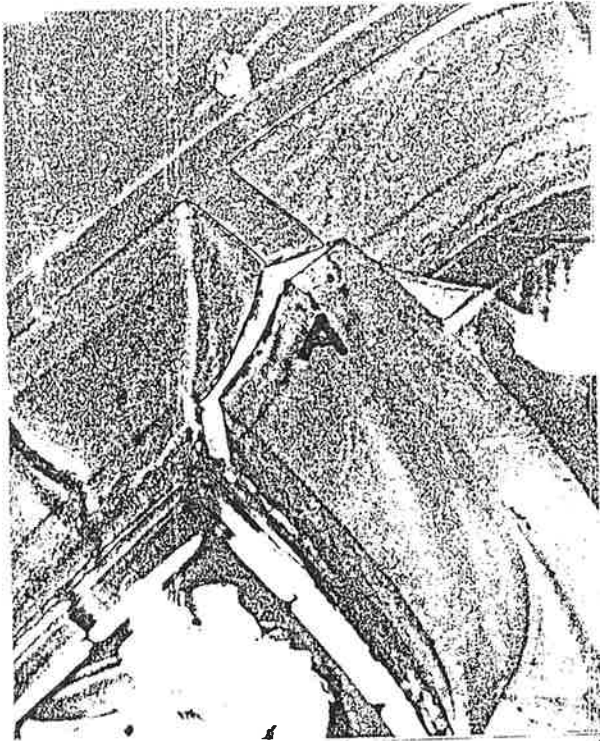
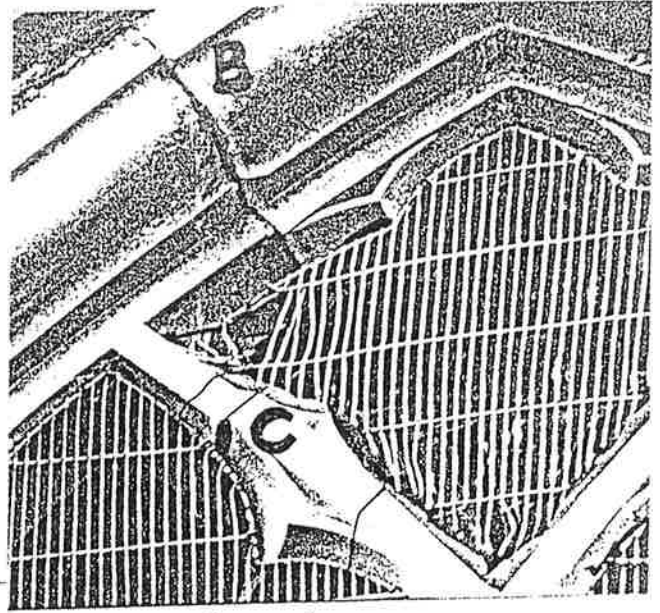
INSIDE  
**A** SLIPPED  
 VOUSSOIR &  
 CURVED MULLION

**B** SLIPPED MAIN  
 KEYSTONE  
**C** CRACKED & SLIPPED  
 VOUSSOIR & CURVED  
 MULLION.

During the restoration of the East Window (W8) a great deal of deterioration of the stone frame and tracery was apparent. Defective stones, such as key stones, visours and so on were either repaired or replaced to ensure a sound frame for the reinstallation of the window panels.
