**CONSERVATION MANAGEMENT PLAN FOR THE
ST JOHN'S CHURCH HERITAGE PRECINCT
LANDSCAPE, REID, ACT**

**Prepared by Duncan Marshall, Geoff Butler, Dr Michael Pearson
and Emeritus Professor Ken Taylor AM**

**for the
Anglican Parish of St John the Baptist, Canberra**

2010

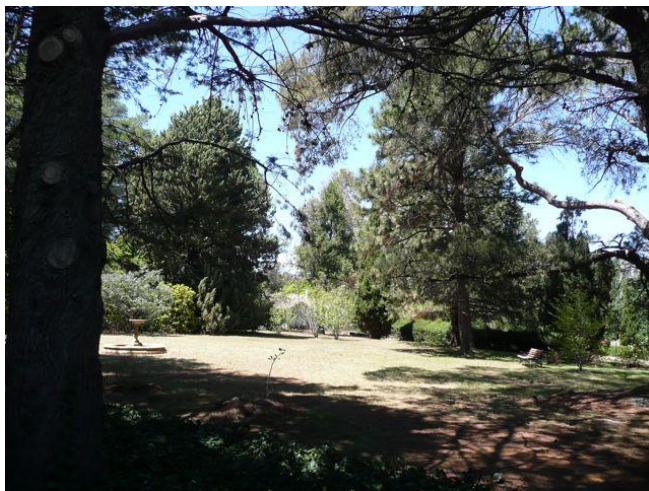
Figure 10. Fountain Lawn – LCU2

Fountain lawn area edged with FCC planting and several other conifers, south of the cypress walk and church, and FCC planted hedge. This forms a pleasantly enclosed space/glade which is much admired for wedding photographs. It has an open lawn with mature conifers with large trunks creating distinctive patterns, as well as light and shade effects.

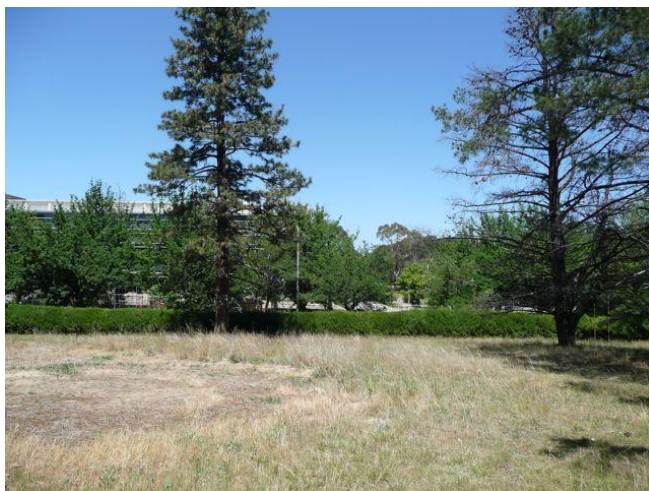
**Figure 11. Horse Paddock – LCU3 –
Natural Temperate Grassland/Golden Sun
Moth Habitat**

Open paddock fringed by trees to form pleasant open space. FCC hedge planting parallel to Constitution Avenue blocks the view from the road into the precinct, as was intended. Filtered view of the church through the trees from the southwest corner.

LCU7	Maintain open graveyard character with views to church building. Replace as necessary Galliard 1880s pines with the aim of having tall trees to continue structure planting character.
LCU8	Maintain open dry grass character and Golden Sun Moth habitat.
LCU9	Maintain irrigated grass and trees.

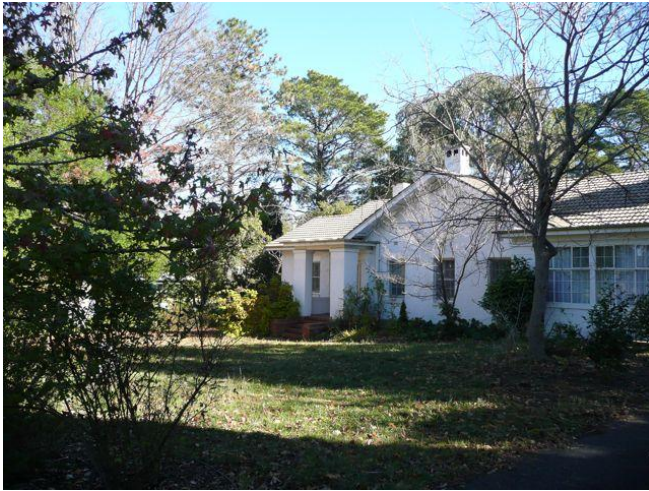
Figure 12. Rectory garden – LCU3a
Source: Duncan Marshall

Rectory garden area. This garden and house occupy an integrally important part at the southeast corner of the site. Currently the garden is overgrown, but with a wilderness effect that merges visually into LCU 6. It has a residential garden character.

The vegetation of the rectory garden (LCU 3a) is an amalgam of plantings over time. It is of little heritage significance, and in some cases poses a direct threat to the building. The Ponderosa and Monterey Pines (*Pinus ponderosa* and *Pinus radiata*) on Constitution Avenue and wildling eucalypts, together with large shrubs located against the building are examples. There have been several fires in the churchyard over the years, including a substantial fire in mid-2008 in the eastern part of the horse paddock. These have prompted a fire hazard report for the precinct (Cartwright 2009).

It is recommended that the vegetation contained within the rectory garden be viewed as a separate entity to the historic plantings of the remainder of the precinct. The main considerations for the rectory garden should be to maintain it as a residential garden but within a framework of plantings sympathetic to the churchyard and the street views of the churchyard, and reducing the potential for fire damage to the built infrastructure.

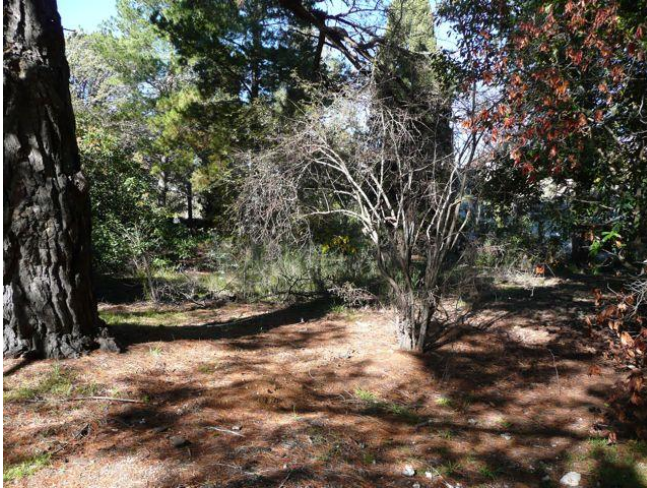
Figure 15. Former orchard area, 'Old Orchard' – LCU6

This former orchard area is an overgrown area of landscape edged on southern and eastern sides by FCC plantings. Currently it presents an untidy, unkempt feel.

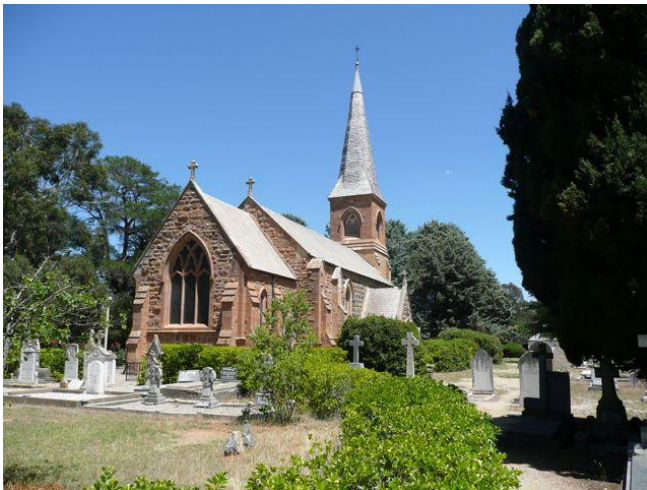
Figure 16. Graveyard – LCU7 – Euonymus hedge in foreground

Main open area of graves on eastern and northern sides of the church which includes five mature pine trees planted by Reverend Smith, and other individual trees. Impressive views from the eastern fringe to the church. Expansive area relative to the rest of the site. Individual trees need provenance to analyse if any have historic connections. Trees planted by Reverend Smith are at the stage where action is needed in relation to their longevity, safety and threat to graves. This area includes the shrub hedge on the north of the church.

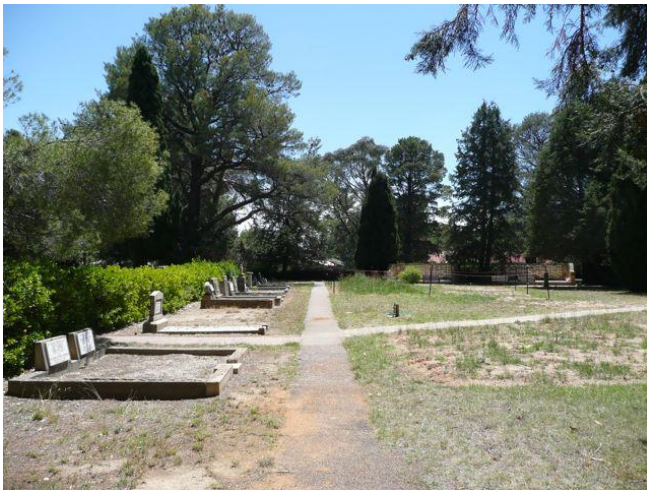
Figure 17. Graveyard adjacent to Anzac Park West – LCU8

An open grassy entry area from Anzac Parade/Anzac Park West enclosed by FCC hedges. It is an important sense of entry and address to the precinct with a view of the church building dominating it visually. The area also has potential ecological values and significance as possible habitat for the Golden Sun Moth. The nearby nature strip has been identified as a habitat of the Golden Sun Moth (Biosis Research Pty Ltd 2007a) and it has been suggested (David Hogg Pty Ltd 2007) that it could be extended into the cemetery area

on this open grassy strip. Active steps are under way to re-establish the original native grassland here, as additional Golden Sun Moth habitat.

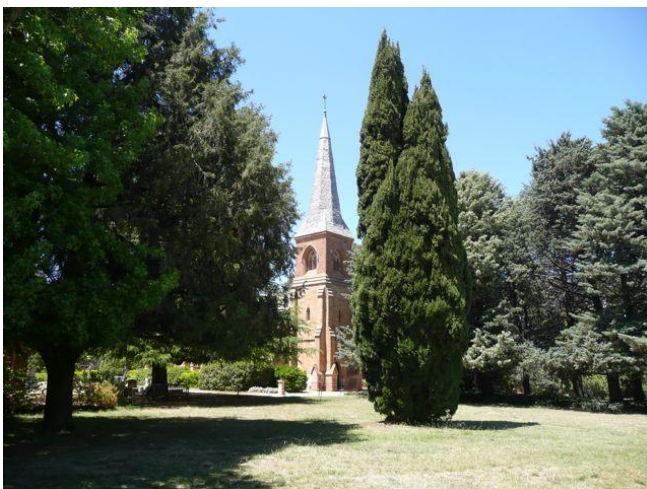
Figure 18. Lawn area – LCU9

Lawn area which creates boundary to LCU 8 forming physical and visual link (View f) to St John’s Schoolhouse. It includes four mature trees which function as a visual screen to the administration complex.

Note: With the exception of the far left tree, all others visible are 1920s plantings.

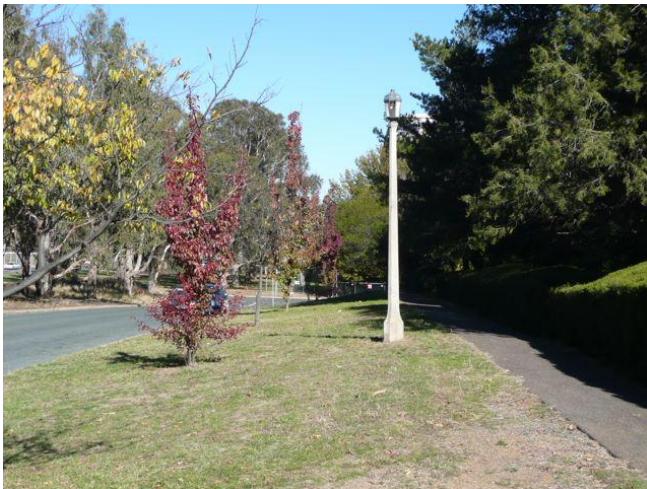
Figure 20. Anzac Park West verge – LCU11

The grass verges and street trees along the internal road and two fringing roads of Constitution Avenue and Anzac Park compliment the landscape character and setting of St John's creating appropriate edge definition between the public domain and the churchyard. The street trees on Constitution Avenue consist of English Oak (*Quercus robur*, an NCDC planting of the late 1960s), Roman Cypress (*Cupressus sempervirens*, FCC 1920s planting) and False Acacia (*Robinia pseudoacacia*, FCC 1920s planting). The verges provide a habitat for the Golden Sun Moth and therefore have environmental significance with implications for LCU 8 within St John's boundary (see above). Planting on the Anzac Park grass verge is Nettle Tree (*Celtis australis*, FCC planting) and Manchurian Pear (*Pyrus ussuriensis*, relatively recent).

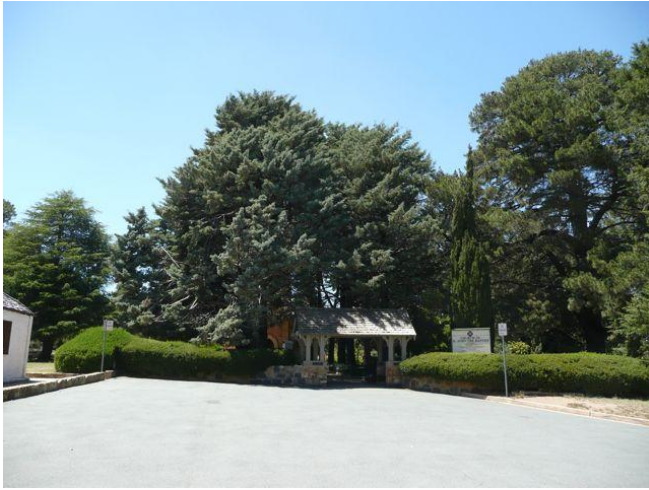
Figure 22. 1920s Cypress entry walk/avenue – LCU1

Note: A 1920 Roman Cypress is to the right of the Lych Gate.

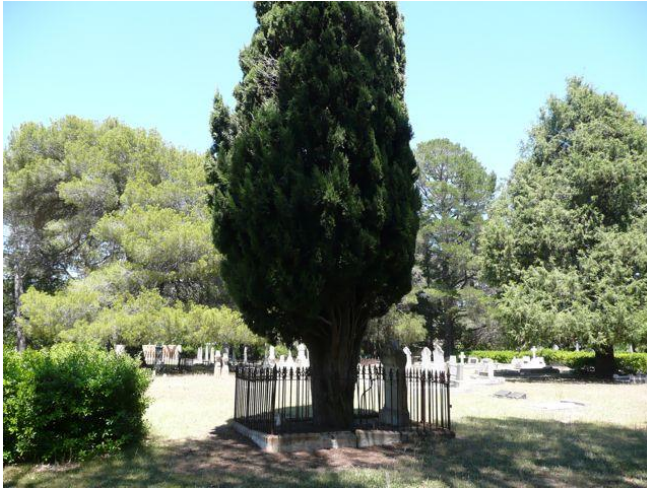
Figure 25. Roman Cypress (Tree 64) growing in fenced grave – LCU7
Source: Duncan Marshall

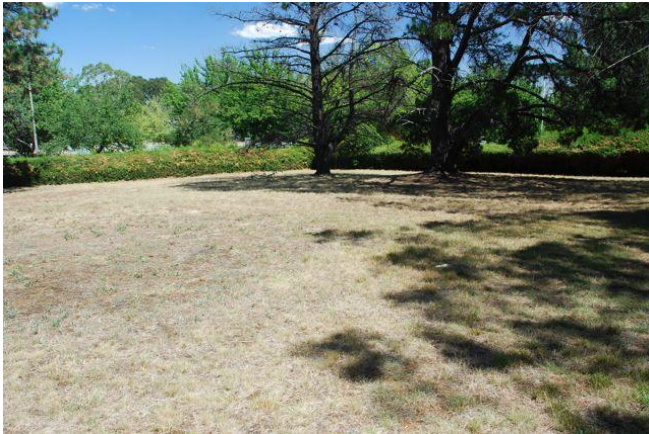
Figure 27. Horse Paddock – one of the native grass areas – enclosed by Himalayan Cypress hedges

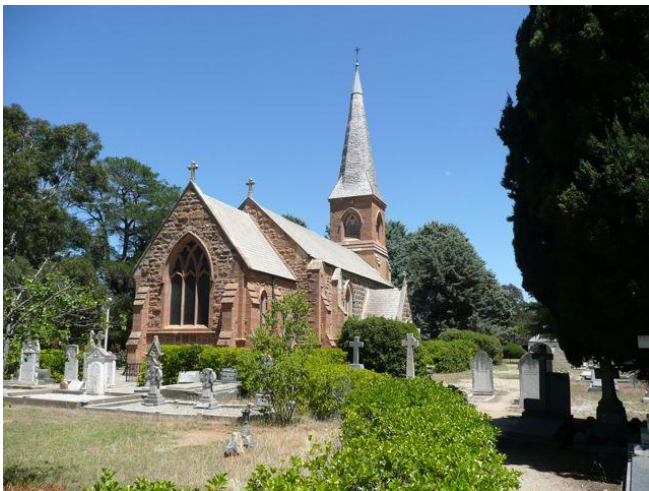
Figure 28. Internal hedge and Shrub Bed adjacent to north wall of Church

This bed consists of Laurustinus (*Viburnum tinus*) and Spindle Tree (*Euonymus* sp.). This bed is probably part of the beautification of the grounds in the 1930s by Archdeacon Robertson. This planting tends to conceal the northern wall of the Church, as seen from the laneway and parts of the churchyard. The plants are still sound.

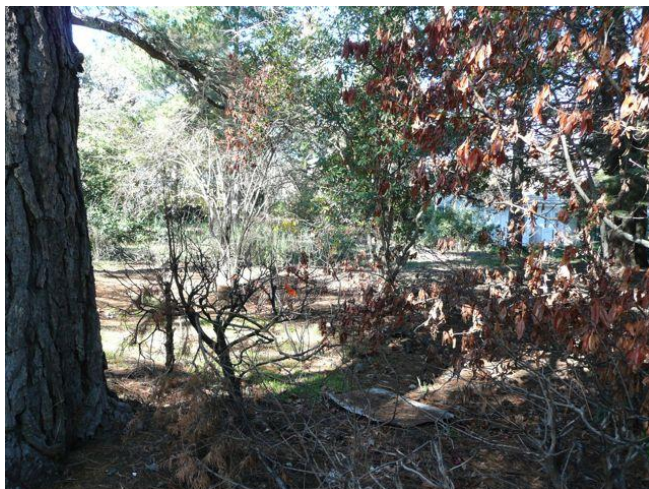
Figure 30. Former orchard area – LCU6

This area is one of the untidiest areas of the site. It is a wilderness of old shrub plantings, an orchard remnant (a Fig tree), wildlings and random plantings. A recent report on bushfire hazard within the precinct indicated the potential of this area as a threat to the Rectory (Cartwright 2009). There was a fire in this area in 2008. Various species inhabit this area (eg. *Photinia serrulata*, Madeira Broom). There is no heritage value to these plantings.

Wildlings (adventitious seedlings) of both trees and shrubs have established in various areas. Some wildling trees can be retained to ameliorate the removal of other trees. However, most are ill-sited, and are recommended for removal. Shrub wildlings are of no real significance, and are growing to the detriment of other significant plantings. Of particular note is the rectory garden and old orchard area. The removal of these species will restore more openness to the precinct and reduce competition to more significant plantings.

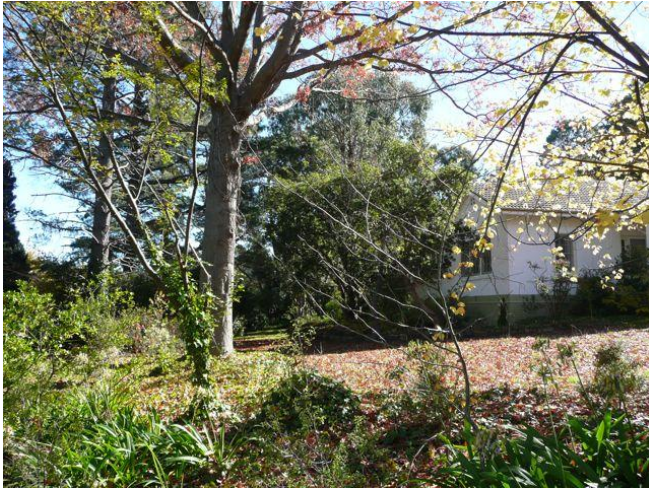
Figure 31. Rectory garden – LCU3a

residential gardens. There is no theme or overall attributes to the plantings over the site. The overgrown nature of the garden was also a source of comment in the bushfire hazard report (Cartwright 2009). The most significant elements in the garden are the two Monterey Pine (*Pinus radiata*) and Pin Oak (*Quercus palustris*) on the Constitution Avenue frontage.

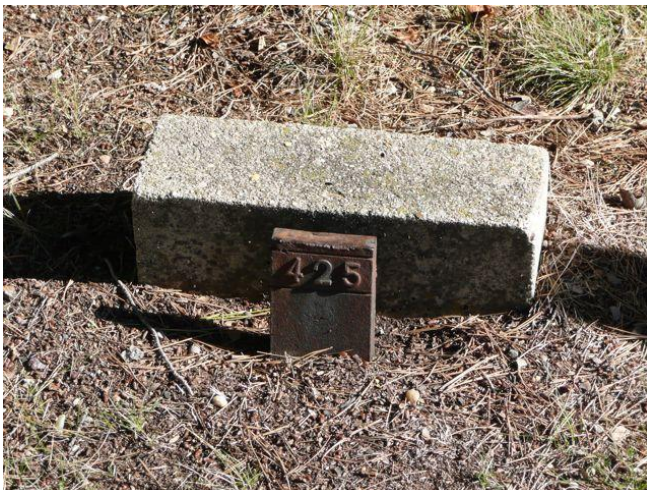
Figure 33. Iron Church Register Plot Markers
Source: Duncan Marshall

Iron Church register plot numbers	Rectangular iron markers placed at the foot or head of a grave to indicate the plot number.	67 plot markers were identified scattered through the graveyard
Seats	20 bench seats of various designs.	Scattered around the churchyard, fountain lawn, Meditation Garden and columbaria.
Stone walls	Stone walls orthogonal to the 1920s block boundary. Built using stone from the old stables block formerly located north of the schoolhouse, built at same time as construction of western lych-gate in 1932.	Stone walls extend each side of the western lych-gate, with the hedge growing over them.

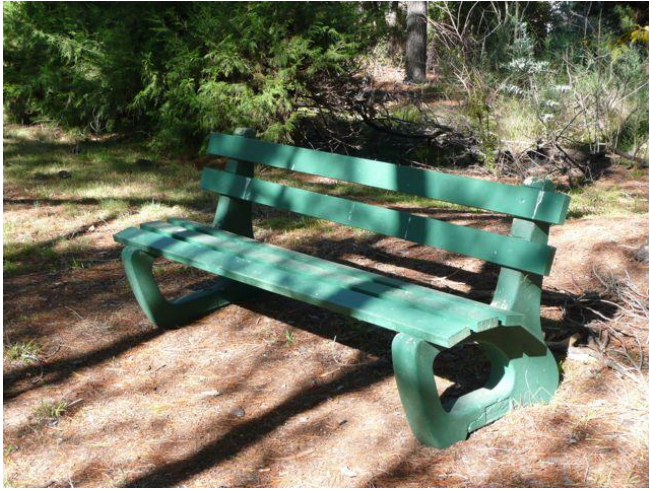
Figure 34. One of the styles of seating in the churchyard

Seats	20 bench seats of various relatively modern/reproduction designs in timber, metal and concrete. The seats are in fair to good condition. See Figure 34.
Stone walls	The stone walls are orthogonal to the 1920s block boundary. The walls extend each side of the western lych-gate, with the hedge growing over them. The walls are in poor to fair condition.
Low stone retaining walls	Low stone walls mark the edge of the lawn area northwest of the church between the schoolhouse and the Parish Centre. They edge the carpark and surround the schoolhouse. The walls are in fair condition. See Figure 19.
Columbaria	Northeastern columbarium: two U-shaped columbarium with random low-height undressed stone walls, ashlar stonework on the interior faces, metal plaques, stone edging, and pebble and concrete paver paving. Southeastern columbarium: L-shaped random low-height undressed stone wall with ashlar stonework internally, metal plaques, low brick walls and edging, and pebble and exposed aggregate precast unit paving. The columbaria are in fair to good condition.

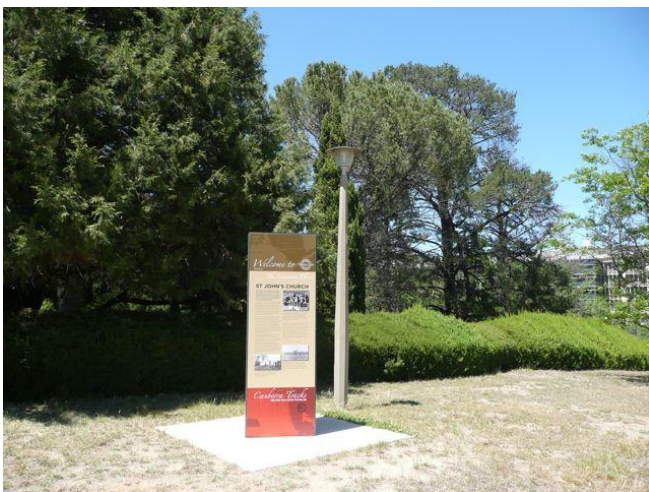
Paths	Numerous paths exist through the site made of concrete, concrete pavers or gravel. The paths are in poor to good condition.
Signage	There are various types of signage including modern painted church and schoolhouse signs, modern metal traffic signs, modern interpretive signs, and an incised stone pillar. The signs are in fair to good condition.
Lights	There are various types of lights including concrete post-top street lights, metal post top path lights, and metal post-top floodlights. The lights appear to be in fair condition.

Figure 41. Modern interpretive pillar sign, and relatively modern post-top street light

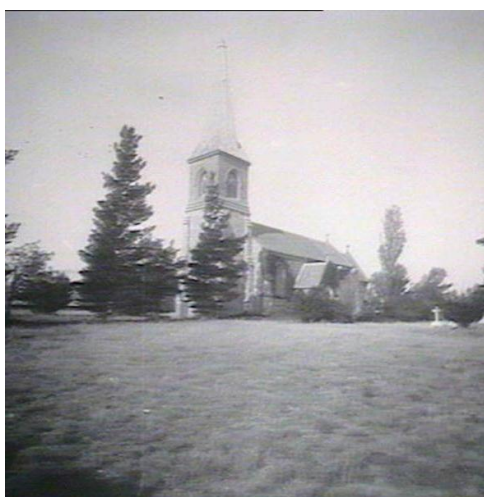
Figure 47. St John's Church, Canberra Estate, 1908

In preparation for the competition for the design of the new Federal Capital to be located at Canberra, the surveyor Charles Scrivener prepared a survey plan in 1909 that shows the Church adjacent the Scott's Crossing road. A photograph of 1908 shows a row of pine trees west of the church tower, and trees and shrubs to the south and east.

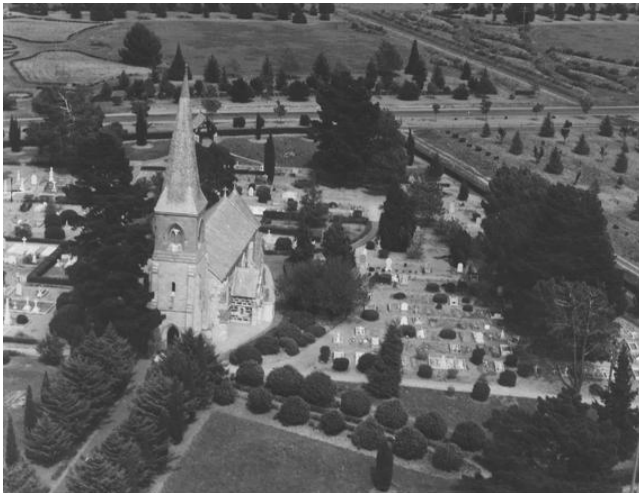
Figure 55. St John's, about 1939

Note: The large pine to the right of the church was removed in 1964. The path and associated plantings at the bottom left of the photograph have been removed.

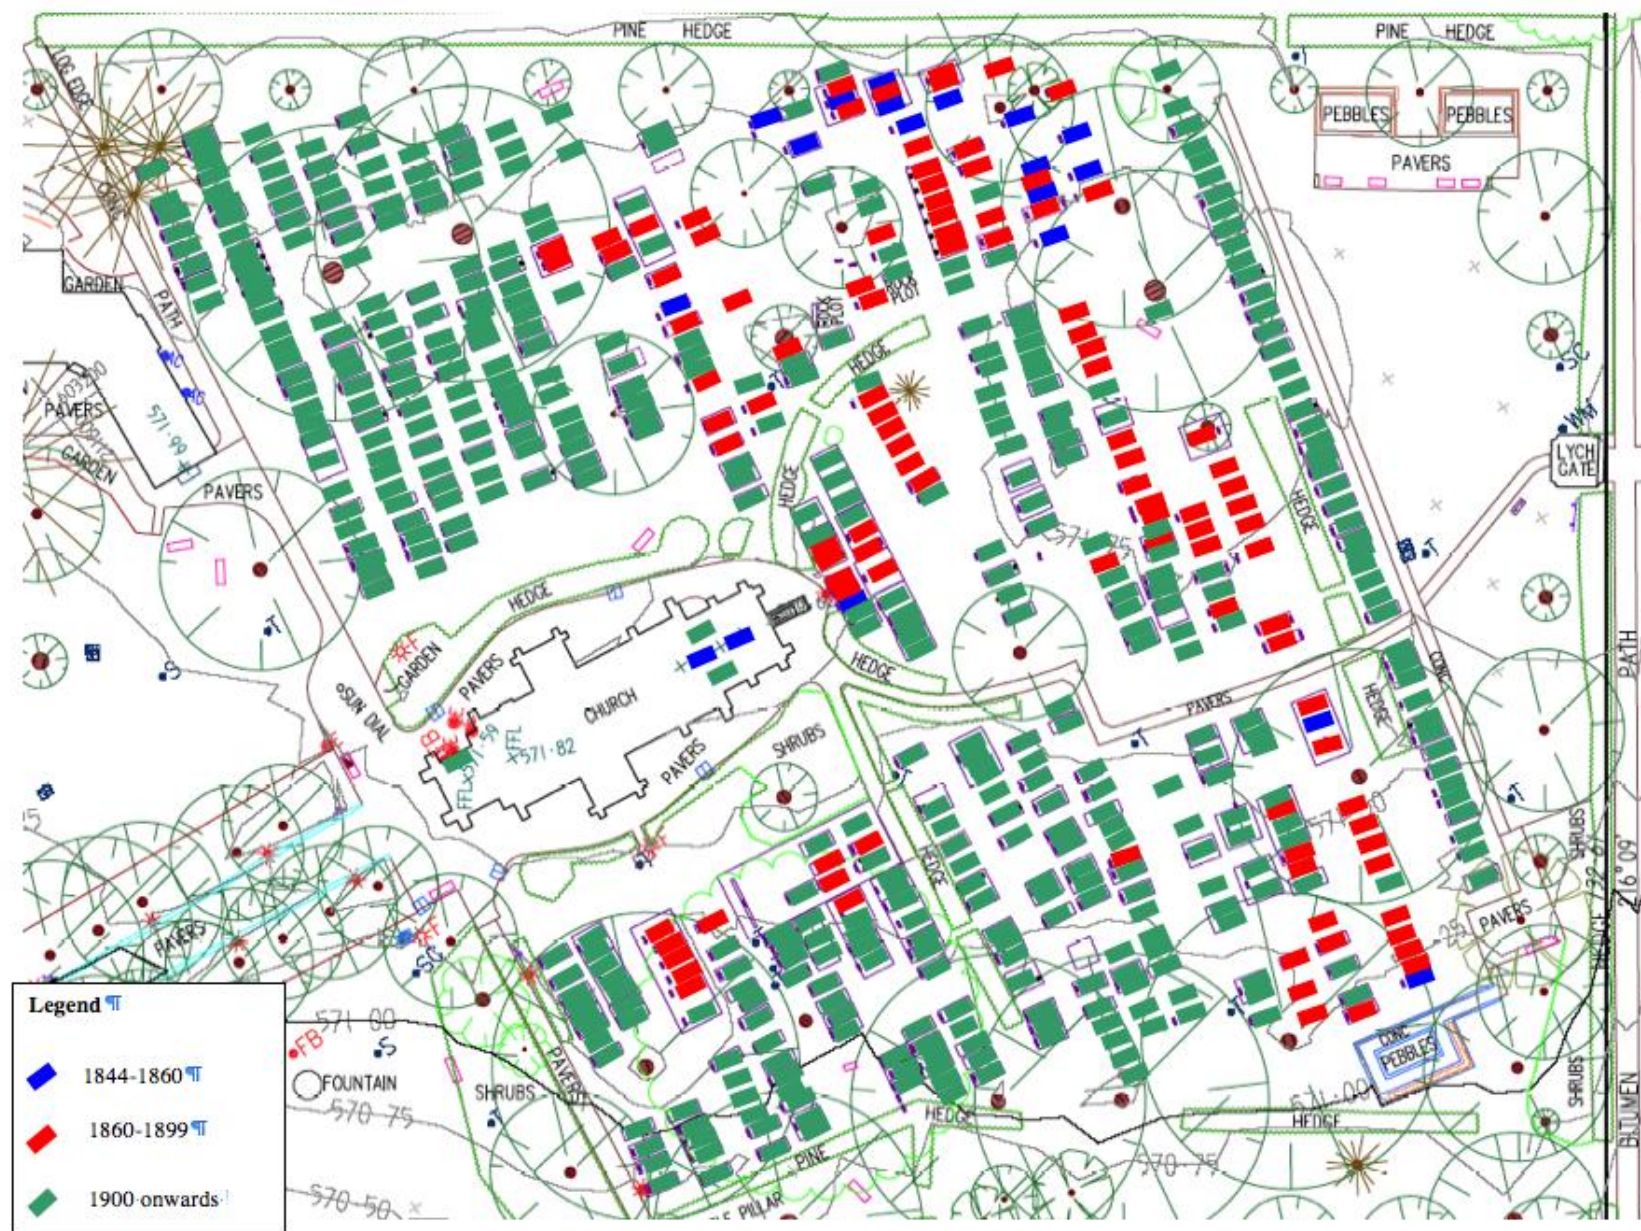
Figure 63.
Development of
Graveyard – Pattern
of Graves by Historic
Period

The churchyard and cemetery have their origins in the mid 19th century, the graves being laid out roughly orthogonal to the original churchyard boundary, and thus at a diagonal to the current St John's precinct perimeter. Different sections of the cemetery have slightly different grave orientation. Up to the 1860s graves were located predominantly in the northeast sector of the churchyard (Section C, see the plan at the back of Salisbury 2000), with a few graves adjacent to the church itself (later relocated in the crypt beneath the eastern extension), and in the southeastern sector (Section H). Between 1860 and 1900 graves extended across the eastern side of the churchyard and the north of the eastern end of the church, with some family plots to the south of the church. During the twentieth century graves were placed throughout the churchyard area. Figure 63 below indicates the location of graves over time.

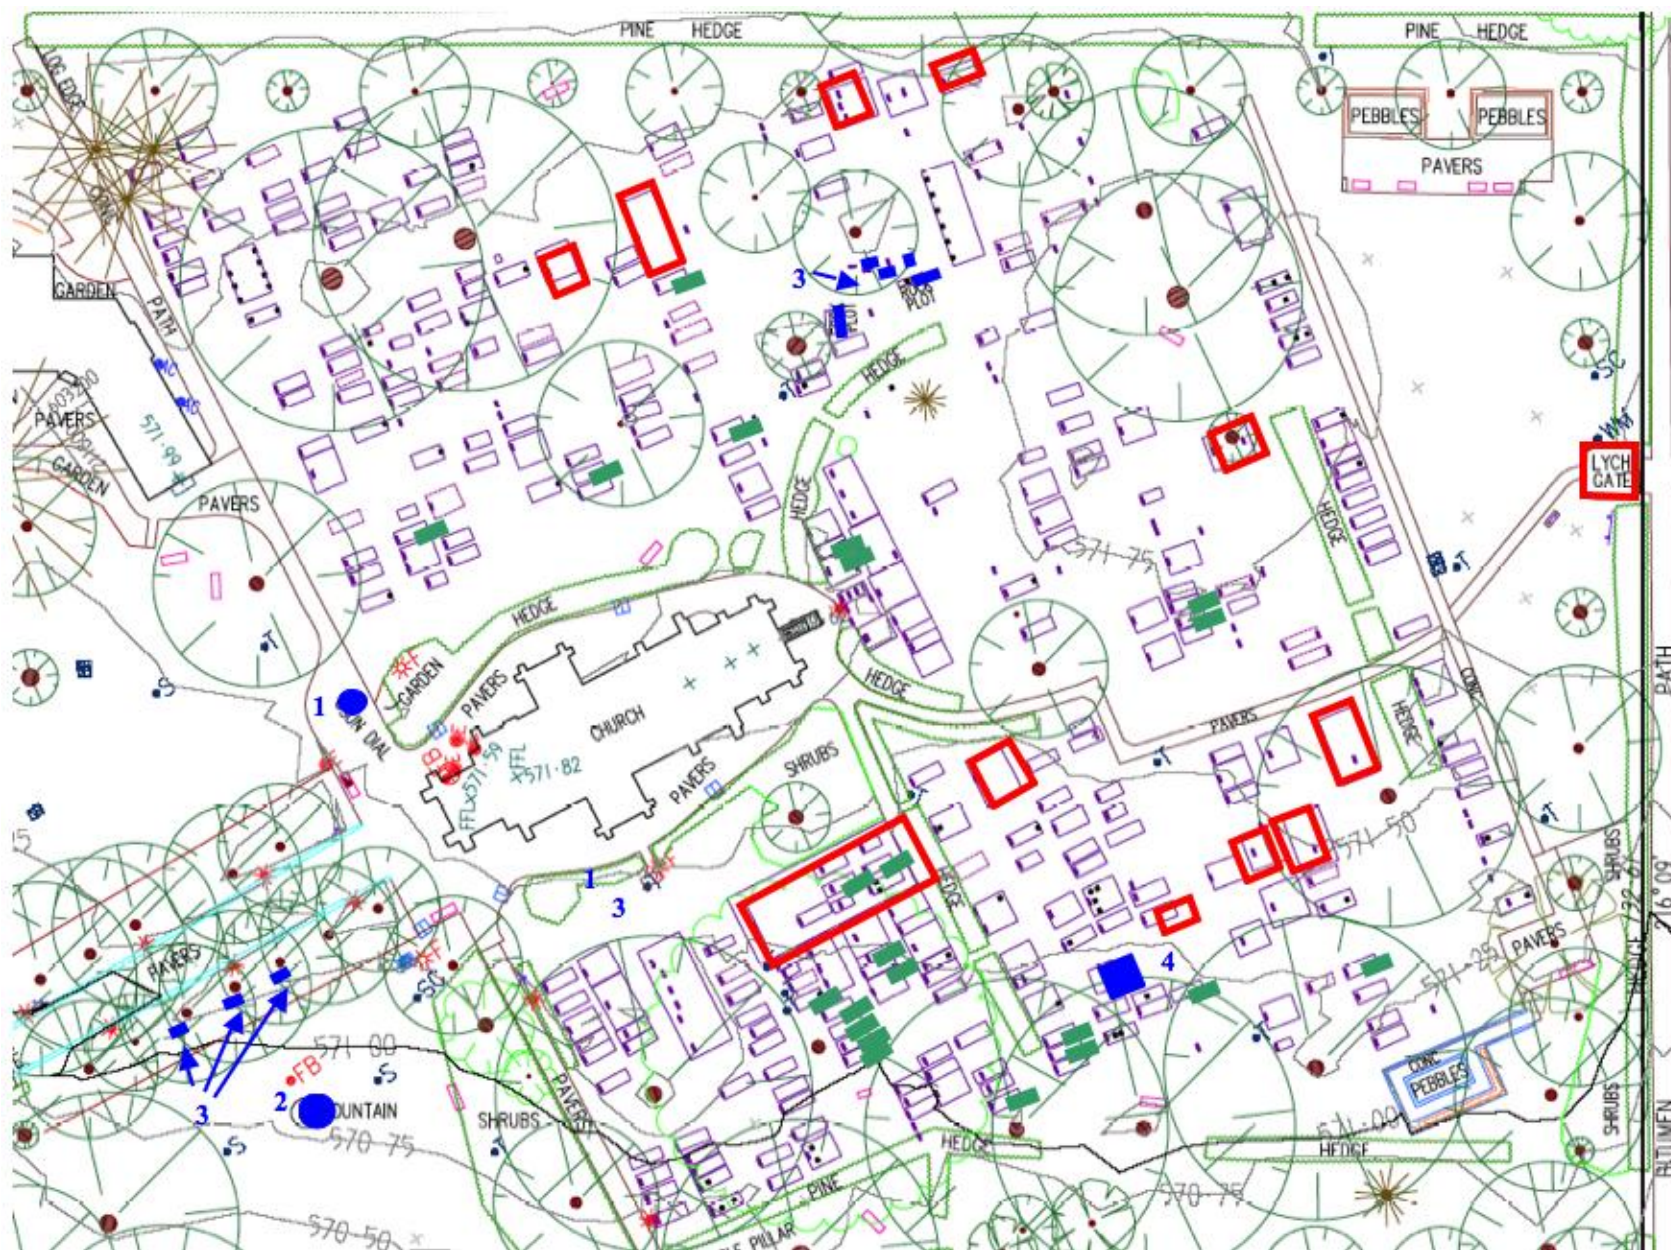
Figure 64. Grave Fences, Subsidence and Features

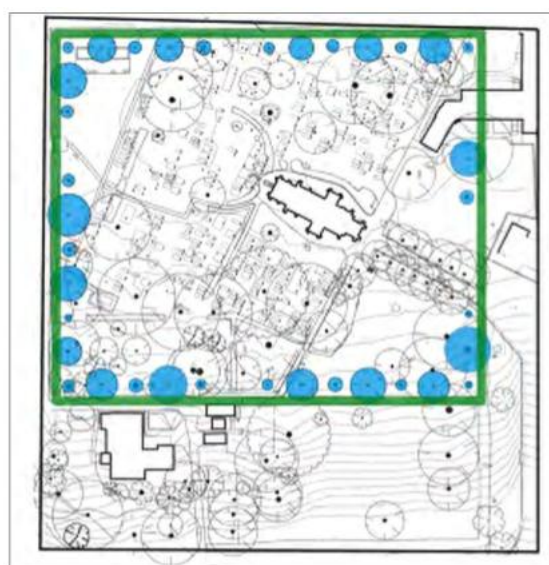
Figure 68. 1920s boundary plantings
Source: Peter Freeman Pty Ltd 2007

- **1920s** – the avenue of Arizona Cypress with rear rows of Roman Cypress leading to the church planted in September 1920, cypress boundary plantings (37 in number) assumed to have been planted by the Federal Capital Commission (FCC) under the direction of Charles Weston in 1926, and 1930s hedge planting by the FCC with its distinctive clipped coniferous/evergreen form. The FCC boundary trees have a similar function to the 1880s pines – although they were enclosing more than just the graveyard but the open landscape areas of the churchyard as well as the old orchard. Other plantings in this period marked the boundary of the horse paddock. The overall character created by this structure planting is seen in the 1940s aerial view (see Figure 57). The row of Roman Cypress behind the Arizona Cypress on each side of the avenue no longer exist. In addition to plantings related to the church property, street plantings in this period of Roman Cypress and False Acacia contributed to the overall character.

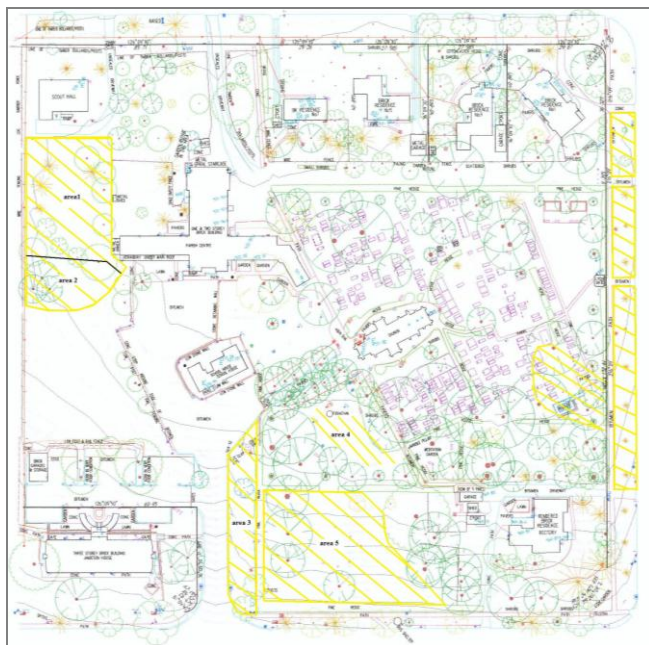
Figure 72. Areas of Habitat for the Golden Sun Moth at St John's based on data at 2007

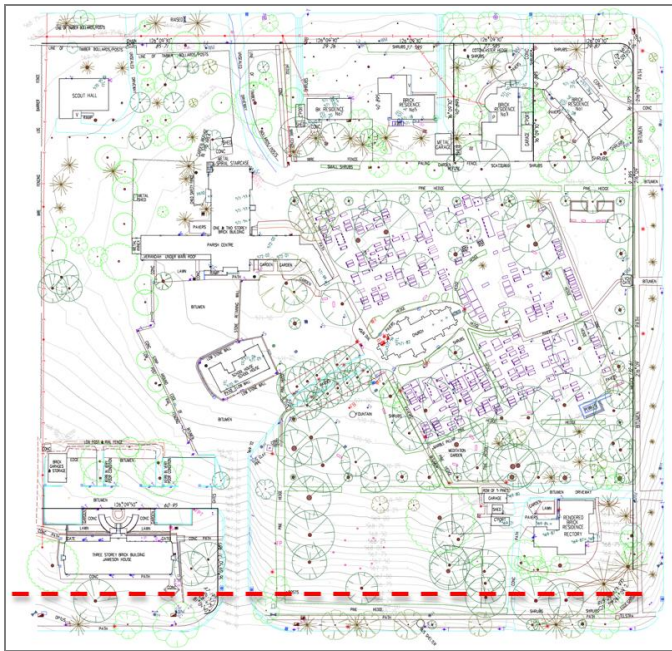
Figure 78. Impact of Road Widening on the St John's Site

Note: New site boundary along Constitution Avenue shown as dashed line.

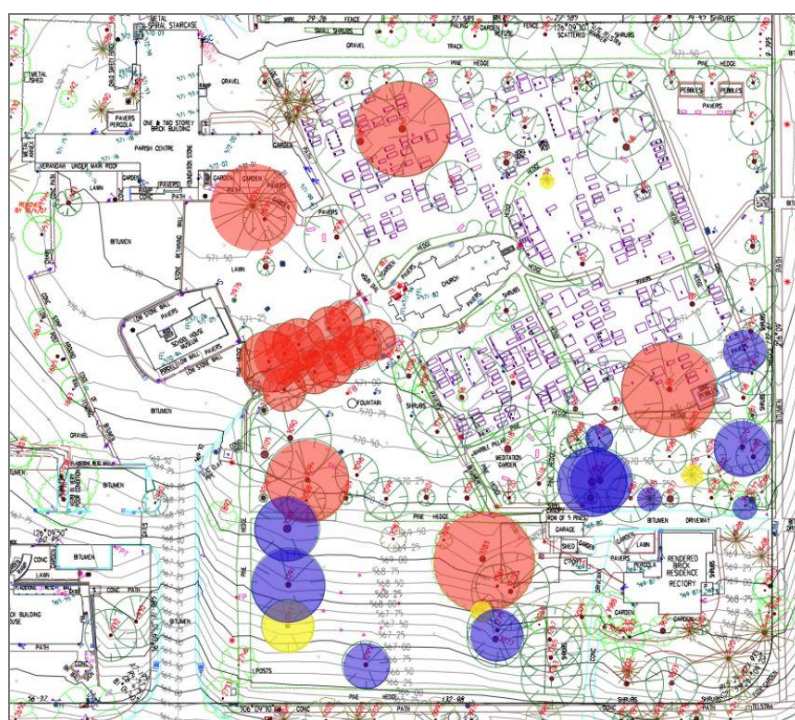
Figure 81. Tree Issues

Table 13 in Section 9.3 below provides details on the tree health and safety assessment. There are a number of trees of various planting phases that need to be removed for safety reasons, because they are dead or of very poor form/health, to better conserve the values of the precinct, or to prevent damage to grave sites or other features. The table also indicates the replacement species where appropriate.

Table 13 in Section 9.3 below provides details on the tree health and safety assessment. There are a number of trees of various planting phases that need to be removed for safety reasons, because they are dead or of very poor form/health, to better conserve the values of the precinct, or to prevent damage to grave sites or other features. The table also indicates the replacement species where appropriate.

It is recommended that trees to be replaced are replaced with Roman Cypress (*Cupressus sempervirens*) in the case of the 1880s pines, the Horse Paddock trees be replaced with the same species as currently exist, a suitable deciduous tree in the case of the Sweet Gum (*Liquidambar styraciflua*) near the Parish Centre (eg. a Chinese Elm (*Ulmus parvifolia*)), and Roman Cypress (*Cupressus sempervirens*) otherwise. The Roman Cypress is highly suitable for a variety of reasons, and will avoid the problems posed by some of the old and

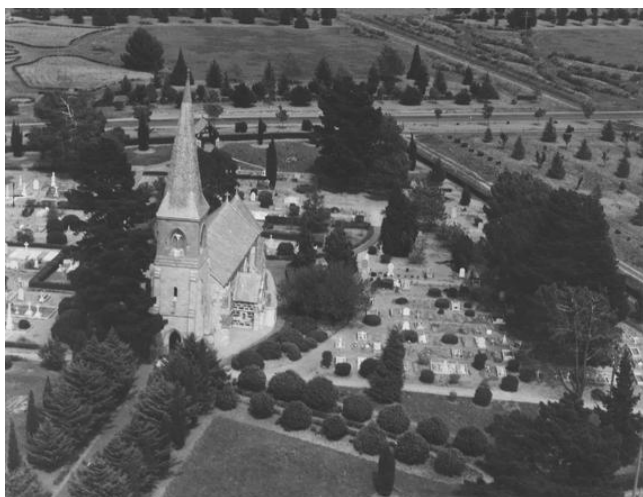
Figure 82. St John's, about 1939 – Cypress Avenue at lower right

The Parish is also concerned to keep some visual openness and connection through the avenue planting, for example to enable parents to keep an eye on children playing in different parts of the churchyard. A double row planting of Arizona Cypress in the inner row with an offset outer row of Roman Cypress would probably create a dense wall effect, when viewed from the lawn areas on either side of the avenue, and would not allow such a visual connection.

Accordingly, an option would be to replant just the Arizona Cypress with no Roman Cypress, and also not to replant the trees closest to the church and the lych gate, using rows of 5 Arizona Cypresses rather than the original 7 trees – Option 2. This might entail some variation on the tree spacing as well. This would be a less accurate reconstruction but an option which responded to the various concerns of the Parish. The existing visual openness and connections would probably be maintained and the option would be a lesser fire risk.

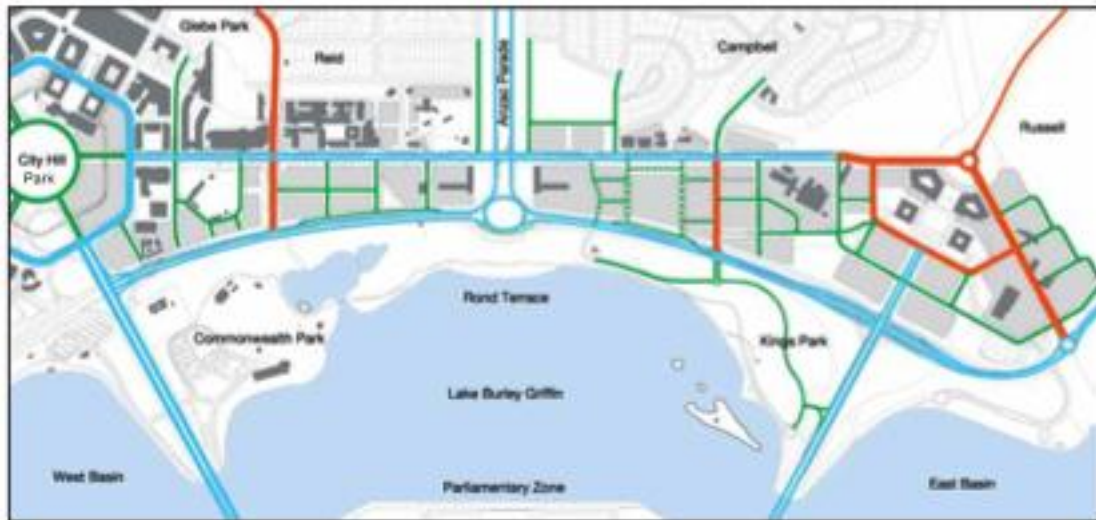
Indicative Road Structure

The road hierarchy provides a legible and connective framework for moving throughout the area with:

- Constitution, Commonwealth and Kings Avenues and Parkes Way having the role of principal routes for through traffic and pedestrians connecting other parts of the city to the area.
- Major connecting streets including Coranderrk Street, Blamey Crescent and Sellheim Avenue having a role of providing the main connections from Civic and adjoining neighbourhoods.
- Minor streets having a local access role with priority for pedestrians and cyclists.
- Lanes, shareways and arcades having a service, access and pedestrian network role.

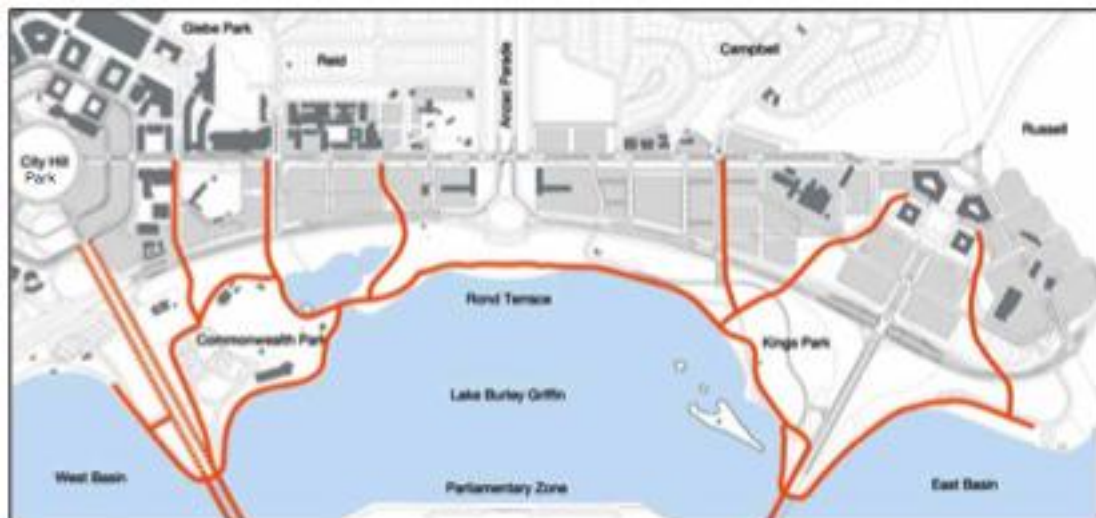
Indicative Cycleways

Provide an attractive and direct network for pedestrians and cyclists catering to recreation and commuter needs, separated spatially and by visual character where appropriate to prevent pedestrian conflicts.
