### 11.1 Structural Report by Northrop Engineers

CR140212e01  
12<sup>th</sup> August 2014

### **St Johns Reid – Structural Audit**

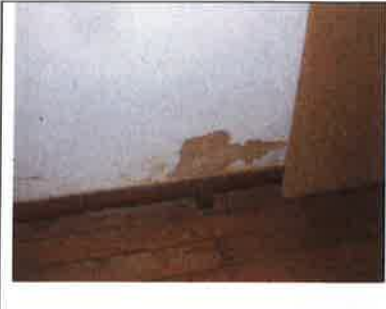
<p>Flaking paint and render, possible rising damp in the dining room.</p>

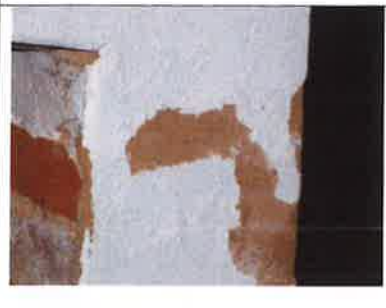
<p>Flaking paint due to rising damp in the utility room.</p>

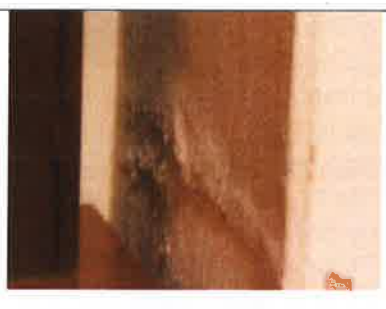
<p>Flaking paint due to rising damp on the living room chimney at the north eastern corner of the building.</p>
